# Appendix

## Bibliography

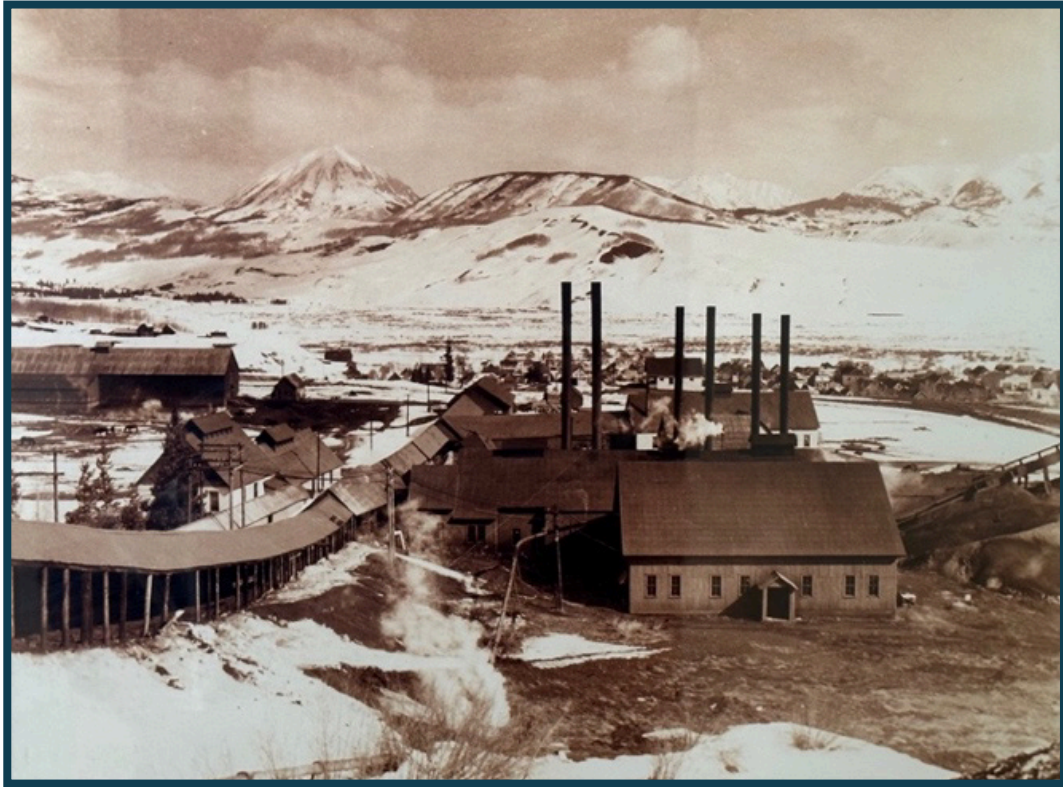
**Big Mine with Crested Butte Below, 1951**

Over the years following the Big Mine's closure, its aboveground features were removed from the site. The only one that appears to have survived to the present day is the former Mule Barn that stands at 709 Maroon Avenue. In its new location, the building was modified and converted to apartments. This left the town with nothing to preserve or interpret at the mine site other than pointing out its previous location on a bench south of and above Crested Butte. What primarily remained from the mining era was the town itself, complete with an array of historic buildings and related features.

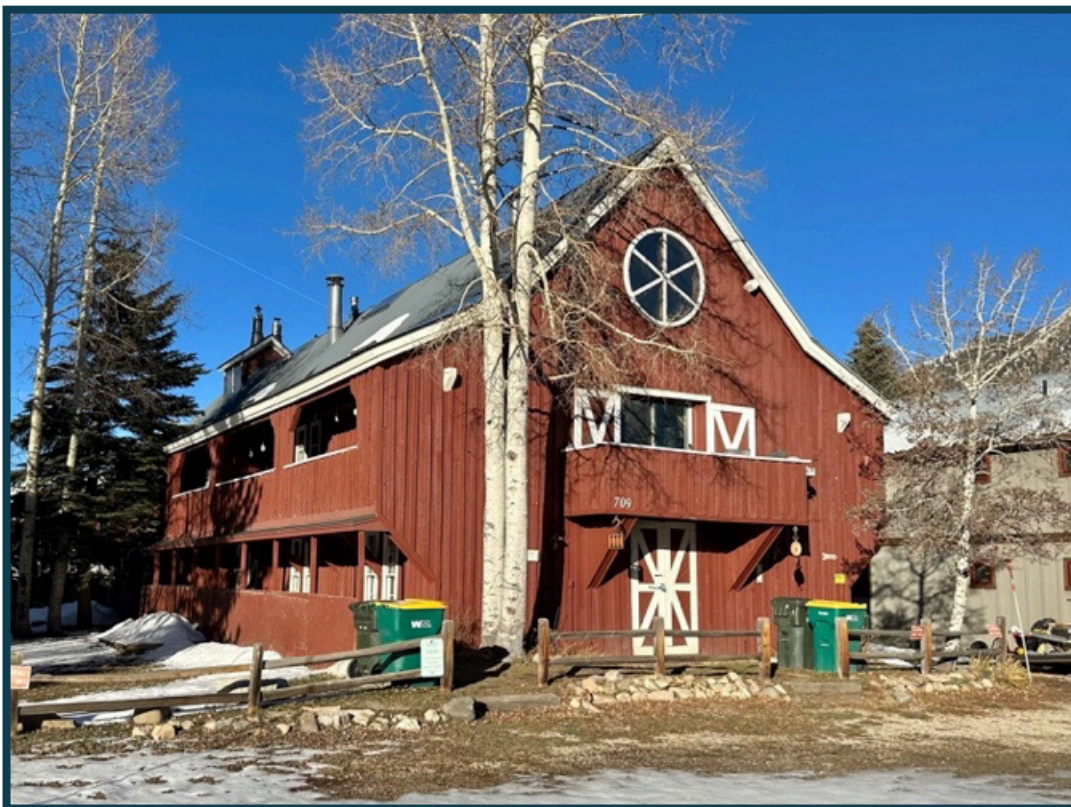
**Mule Barn from the Big Mine  
709 Maroon Ave.**

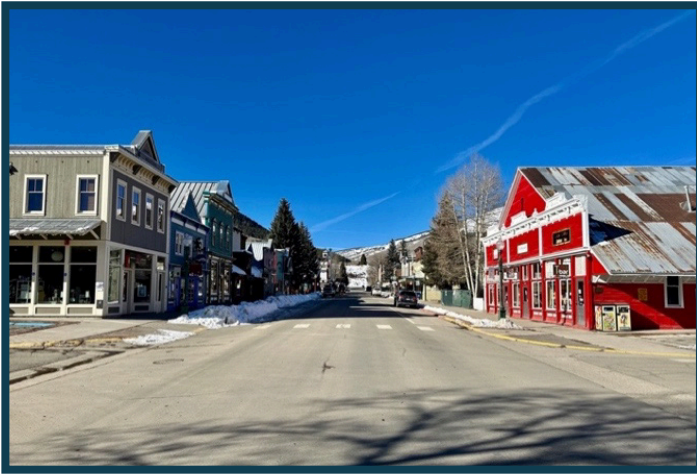
**Elk Avenue  
Looking West from Third Street**  
Credit: Ron Sladek

**Commercial Buildings** were concentrated in Crested Butte's downtown commercial district throughout the mining era. Most of these buildings lined the main east-west thoroughfare known as Elk Avenue. This area extended for just two blocks, from the intersection of Second Street to the intersection of Fourth Street, where the three-story Elk Mountain House hotel (no longer extant) stood on the southwest corner. Elk Avenue was the location of most of the town's offices, service shops, retail stores, restaurants and numerous saloons. Also along its length were the bank, livery stables and a lumberyard.

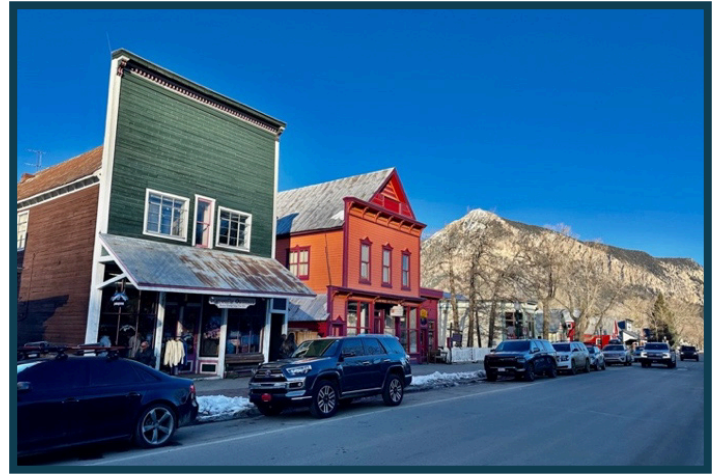
**Commercial Buildings  
300 Block of Elk Avenue (North Side)**  
Credit: Ron Sladek

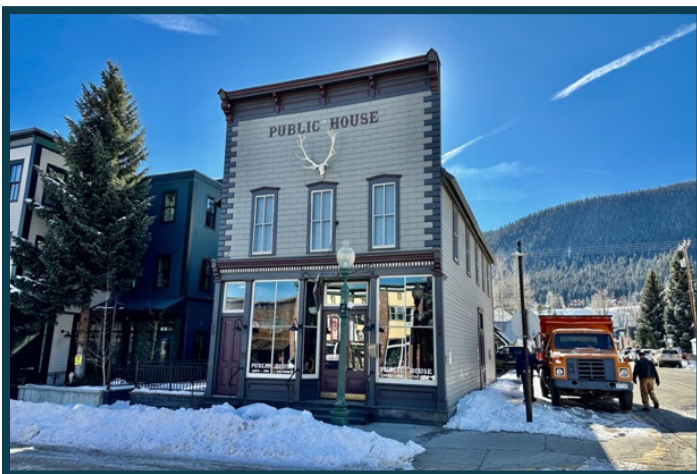
**Crested Butte House and Saloon  
202 Elk Ave., Built 1882**  
Credit: Ron Sladek

Among the oldest commercial buildings still standing are the Crested Butte House hotel and saloon at 202 Elk Ave. and Crested Butte Hardware (now the Crested Butte Museum) at 331 Elk Ave. These date from the early 1880s, the initial period of coal mining in the vicinity. To the rear of the Crested Butte House is an Ice House, constructed around 1900 of locally quarried stone. The small building provided cold storage for the adjacent saloon.

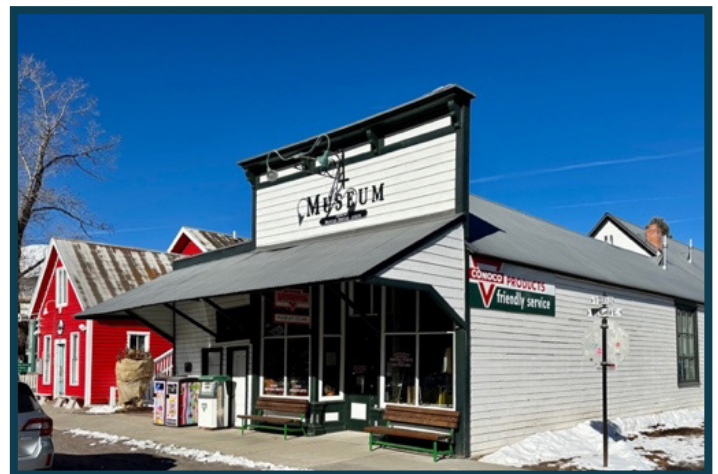
**Crested Butte Hardware / Tony's Conoco  
331 Elk Ave., Built 1883**  
Credit: Ron Sladek

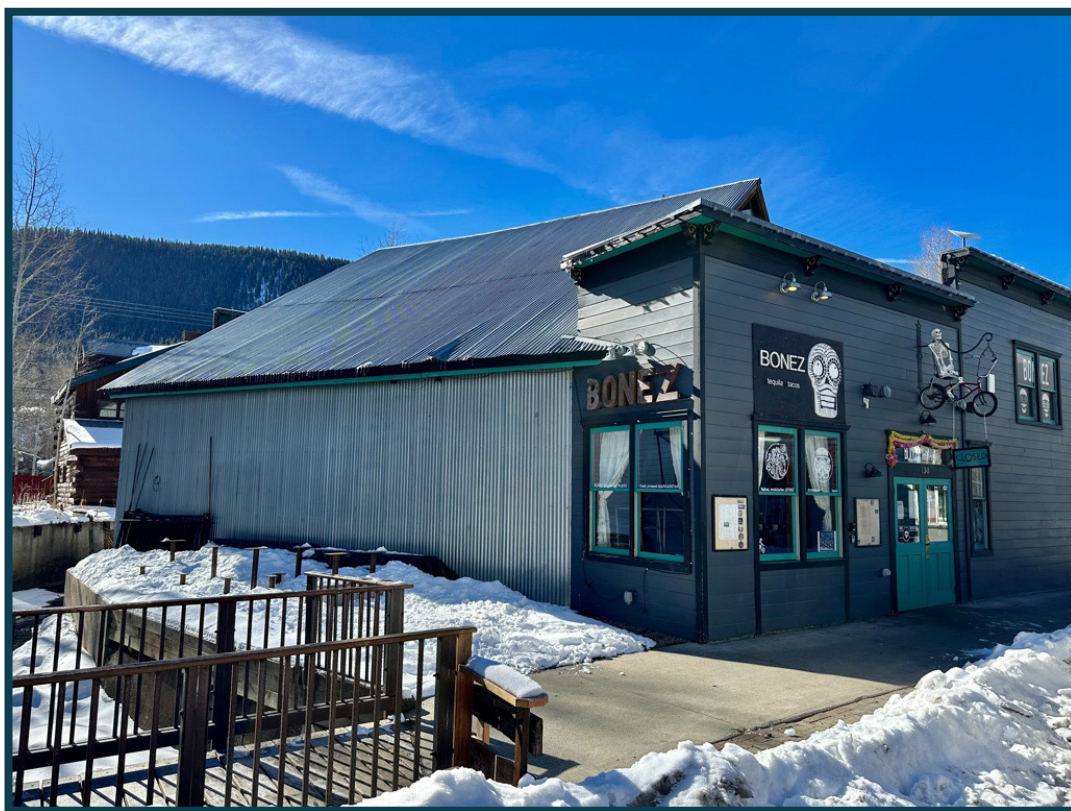
**Crested Butte Light & Water Company, Electric Plant**

**130 Elk Ave., Built 1888-1890**

**Public Buildings** of various sorts were scattered throughout the commercial district and in the residential neighborhoods to the north, south and east. The Post Office was often situated within one of the general stores, a typical practice of the late 1800s and early 1900s. Utilities included the Crested Butte Light & Water Company's electric plant, built in 1888-1890 at 130 Elk Ave. This hydroelectric facility, which operated through 1941, was powered by the movement of water flowing through Coal Creek, with a water wheel used to run its generators. Another public utility was the Telephone Exchange, which occupied a small building that faced onto Third Street just north of the Bank of Crested Butte.

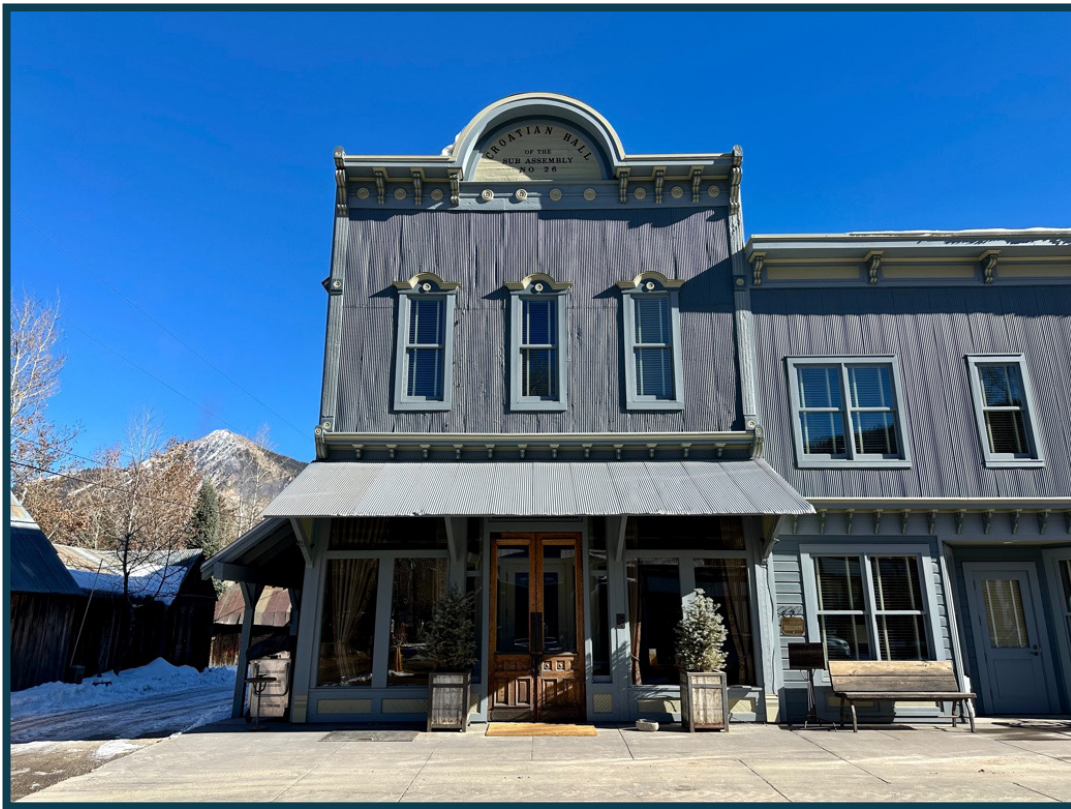
**Croatian Hall / Knights of Pythias Building**  
**512 Second St., Built circa 1885 / Moved circa 1900**

The Croatian Hall / Knights of Pythias Building was built in the 1880s on Elk Avenue. Sometime between 1898 and 1904 it was moved to 512 Second St., where it remains standing today. For many years, the main floor held a saloon and the upper served as a fraternal lodge hall.

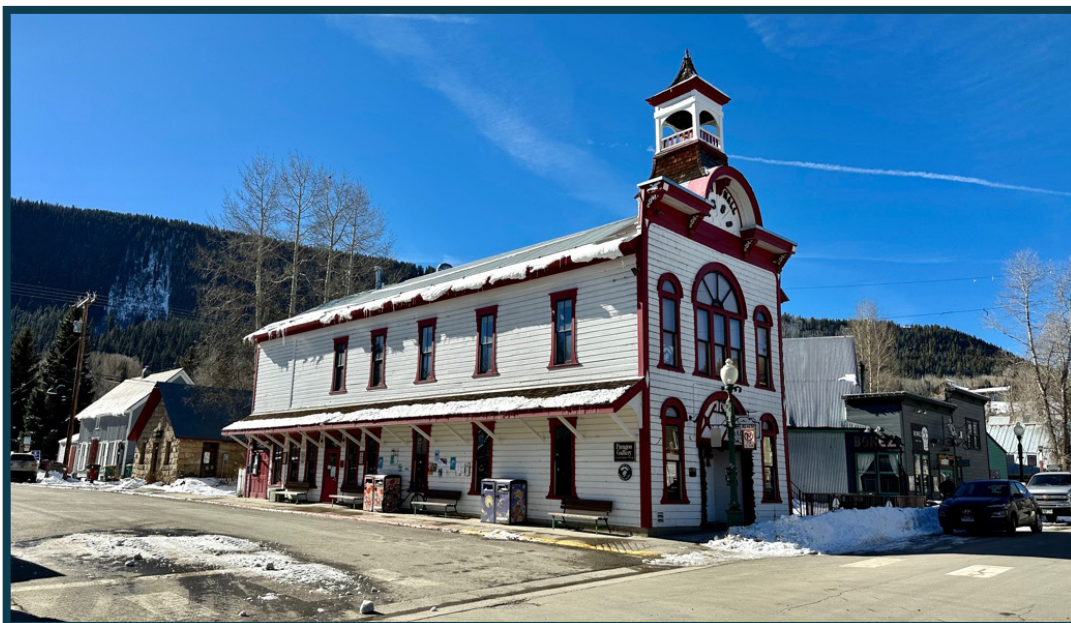
**Crested Butte Town Hall**  
**132 Elk Ave., Built 1883**

Crested Butte's Town Hall, built in 1883, still stands on the southwest corner of Second Street and Elk Avenue. The building provided the town with offices for its administrative functions, a meeting room, and space for the volunteer fire department. A two-story outhouse was attached to the rear. In the 1990s, it was rehabilitated for new use and continues to stand as a prominent landmark in the community. To the south is the sandstone Marshal's Office and Jail. Built in 1883 of locally-quarried sandstone, the building held two jail cells formed of stacked and nailed wood planks. It remained in use, at least periodically, for almost a century.

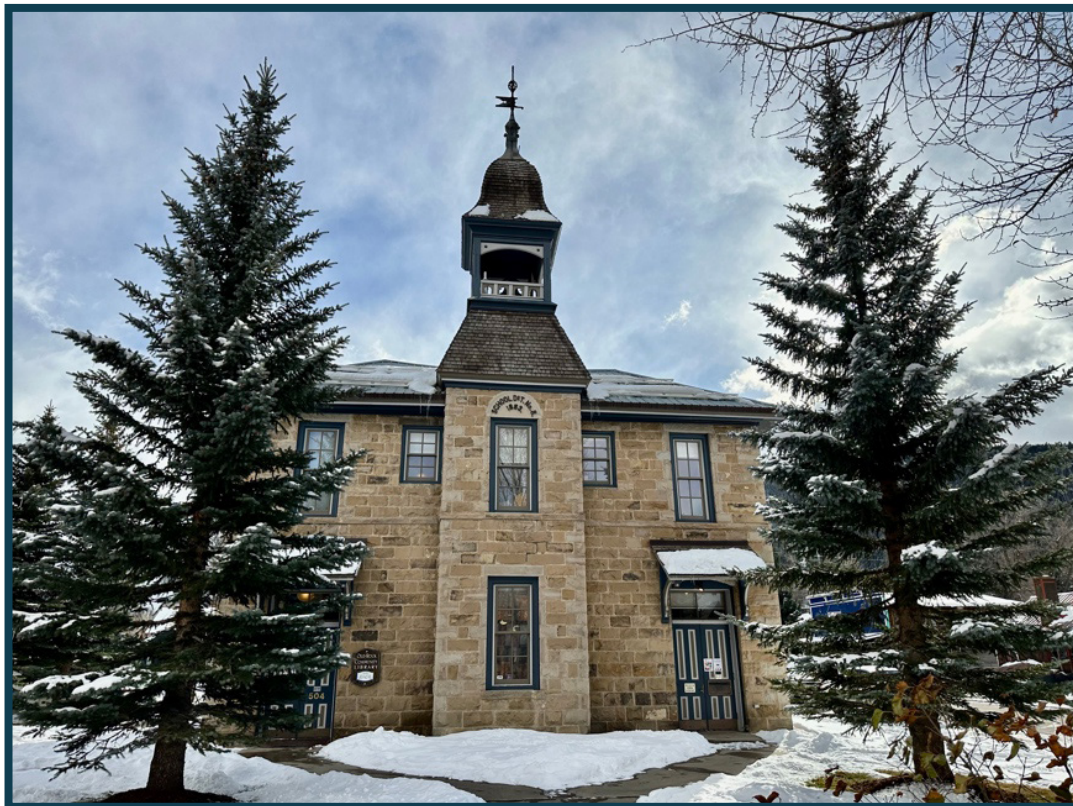
**Rock School House**  
**507 Maroon Ave., Built 1883**

Crested Butte's public schools stood on the southeast corner of Fifth Street and Maroon Avenue. The Rock School House at 507 Maroon Ave. was built in 1883 using stone quarried from the west side of town. It continued to serve the community into the 1920s. The building was rehabilitated in the 1980s and since that time has served as the town's library. A smaller wood-frame school building to the east also held classrooms (it is no longer extant).

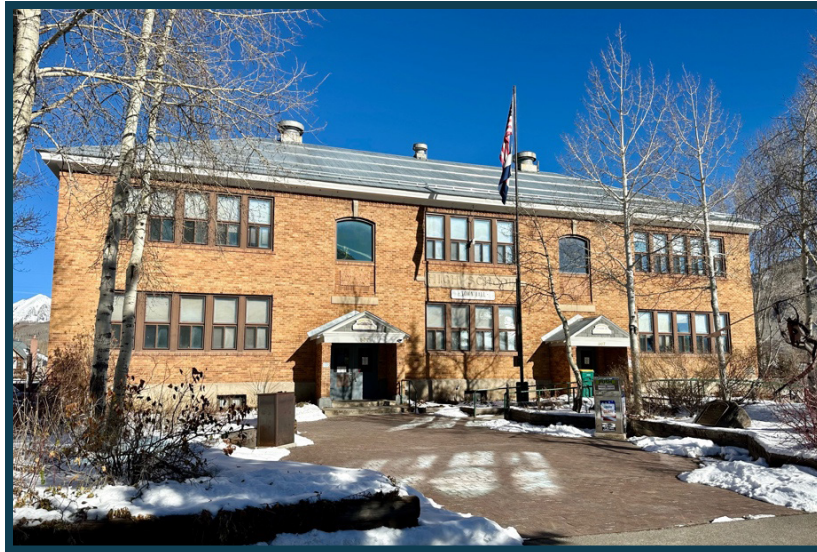
**Crested Butte High School**  
**507 Maroon Ave., Built 1927**

In 1927, work was completed on the new Crested Butte High School, which was built just north of the Rock School House at 507 Maroon Avenue. The blonde brick building was designed by prominent Denver architect John J. Huddart. It served as the community's high school through 1952, when the Big Mine closed and school enrollment suddenly declined. For the next fifteen years, the building housed all of the town's students in grades K-12. It remained in use until 1997 and was then converted to the Crested Butte Town Hall.

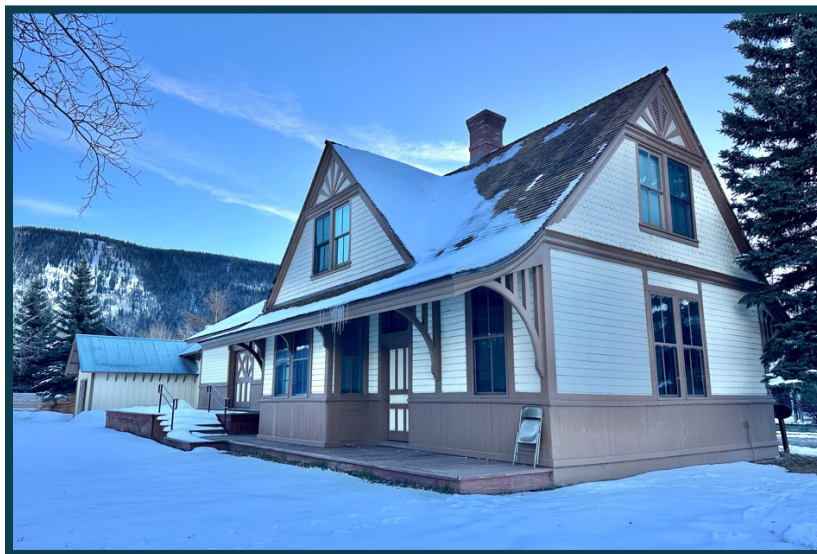
**Denver & Rio Grande Railroad Depot**  
**716 Elk Ave., Built 1883**

The Denver & Rio Grande Railroad Depot was also built in 1883 at 716 Elk Avenue. A narrowgauge railroad line had been completed to Crested Butte two years earlier, connecting the community and its coal mine with the rest of Colorado. The combined passenger and freight depot remained in use until 1954, two years after the Big Mine closed.

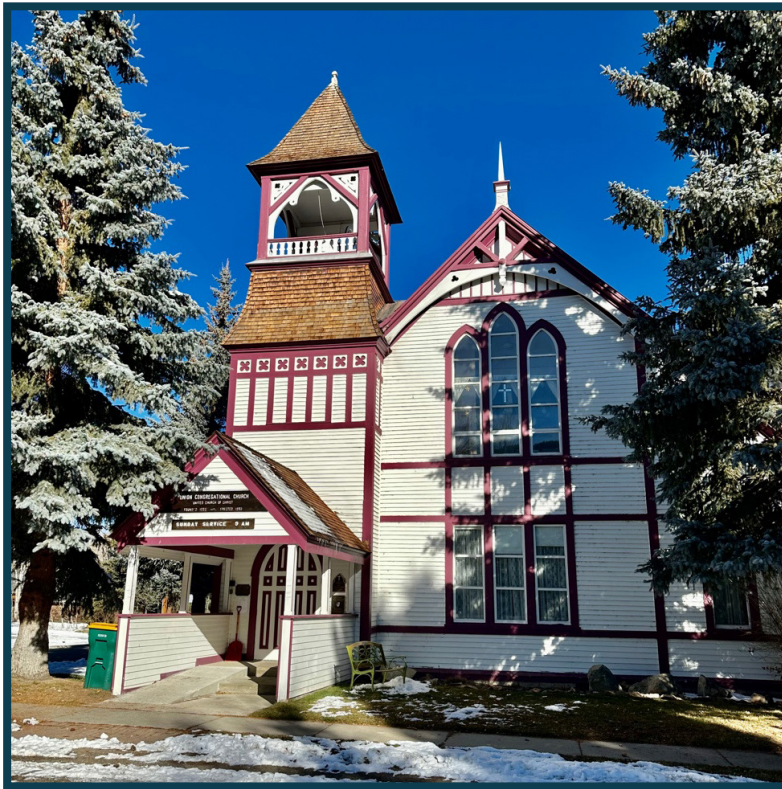
**Union Congregational Church**  
**403 Maroon Ave., Built 1882**  
 Credit: Ron Sladek

Two final mining-era buildings that were open to the public played a central role in the community. The Carpenter Gothic-Revival style Union Congregational Church, one of Crested Butte's most impressive examples of 19th-century architecture, was completed in 1882 at 403 Maroon Ave. St. Patrick's Catholic Church was built at 108 Maroon Ave. around 1890. These wood-frame buildings served the spiritual needs of the town's largely immigrant community and were the scene of numerous life-cycle events. St. Patrick's was sold in the early 1960s and became a private residence. The Union Congregational Church remains in use.

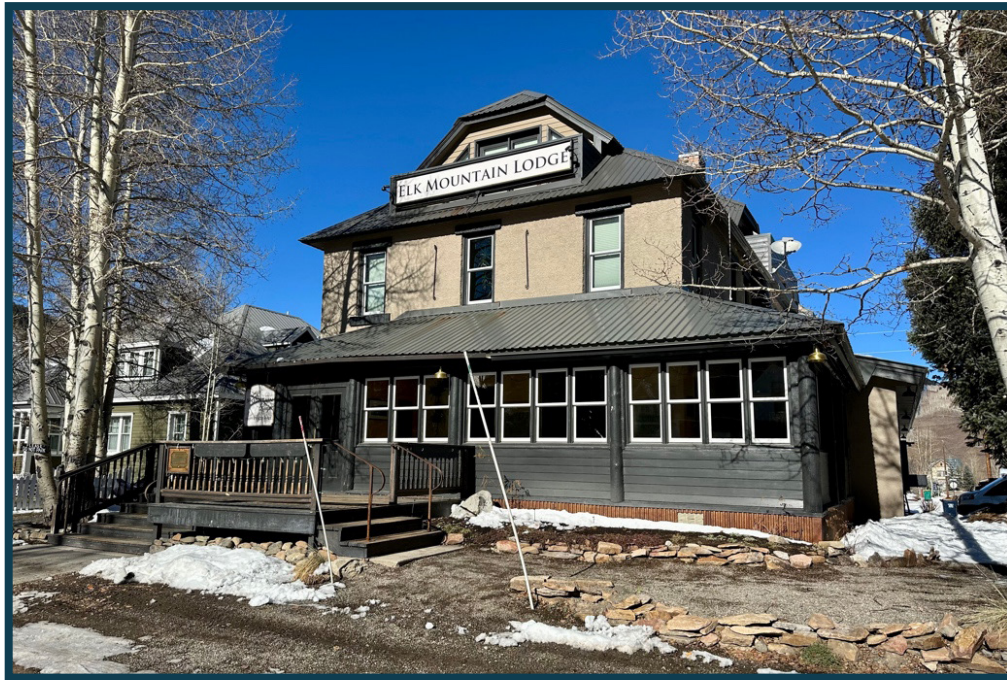
**Colorado Fuel & Iron Company, Boarding House and Hotel**  
**129 Gothic Ave., Built 1919**  
 Credit: Ron Sladek

Boarding House and Hotel (now the Elk Mountain Lodge) at 129 Gothic Ave. CF&I owned the Big Mine and consequently had management personnel, consultants and others visiting Crested Butte on a regular basis. This facility provided them with a place to stay while in town. The building was constructed with cinder blocks formed using slag from the mine, and its exterior walls were stuccoed. In addition to the boarding house and hotel, the company arranged to have houses constructed on the same block to serve as residences for employees.

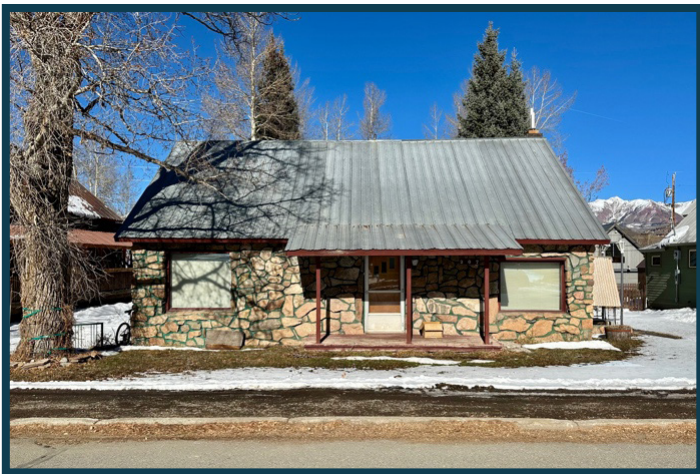
**House Clad in Stones**  
**207 Maroon Ave.**  
 Credit: Ron Sladek

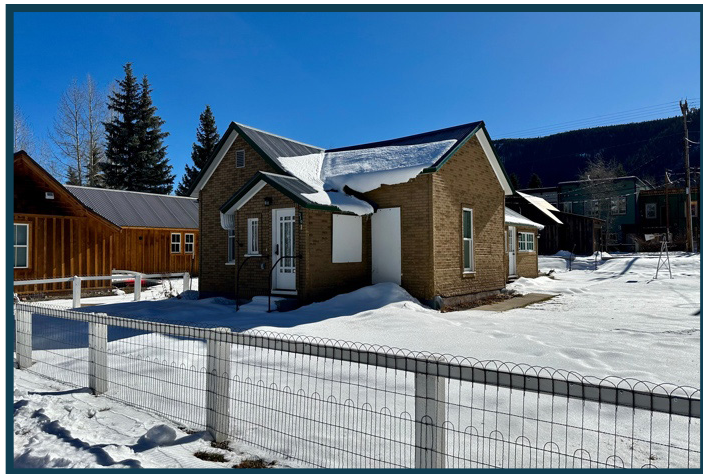
**House Clad in Faux Bricks**  
**210 Maroon Ave.**  
 Credit: Ron Sladek

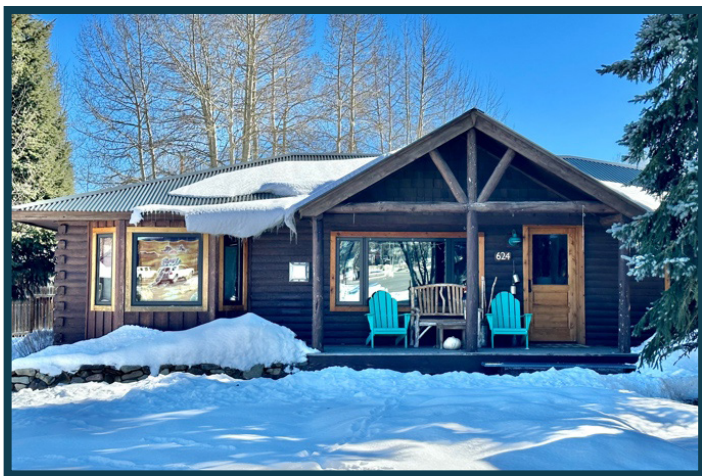
**Rustic Revival Log Residence**  
**624 Elk Ave., Built 1956**  
 Credit: Ron Sladek

**Development in the 1950s and 1960s** was limited to around two dozen buildings. These included about fifteen residences, among which there was no consistency in style although all but one were constructed of wood. They included an A-Frame, three Rustic Revival or Chalet houses built with milled logs or log siding, a brick Tri-Level Ranch House, a Contemporary style two-story residence, and four Manufactured Homes (one of which was soon clad in extensive wood siding and ornamentation). Several of these residences were later enlarged or extensively remodeled. Other properties included a False-Front Rustic Revival commercial building on Elk Avenue and a two-story wood-frame lodge built in the Ranch Style with minimal chalet ornamentation.

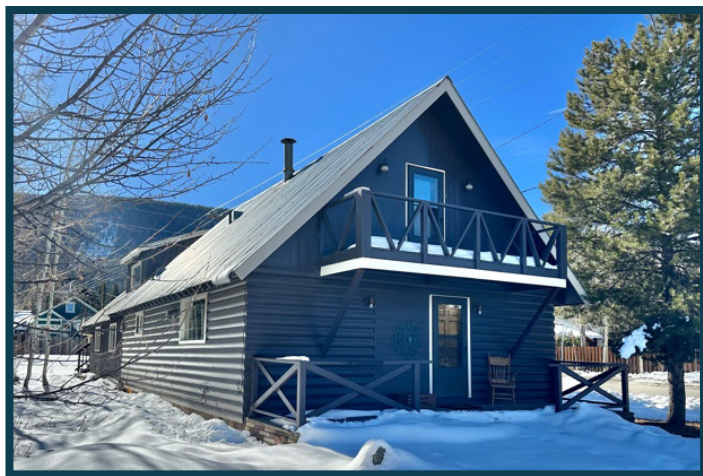
**Chalet Style Residence**  
**102 Teocalli Ave., Built 1961**  
 Credit: Ron Sladek

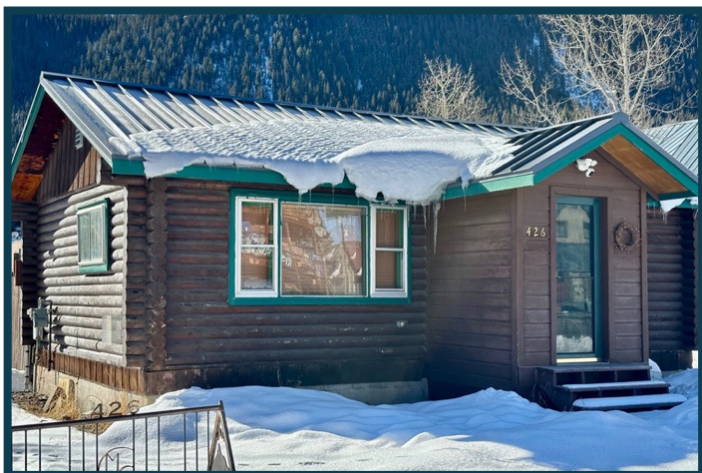
**Rustic Revival Log Residence**  
**426 White Rock Ave., Built 1968**  
 Credit: Ron Sladek

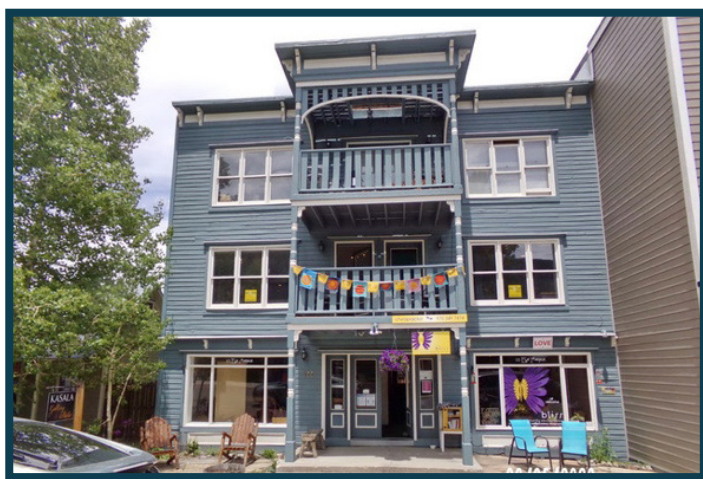
**Commercial Building with Victorian Detailing**  
**111 Elk Ave., Built 1979**  
 Credit: Ron Sladek

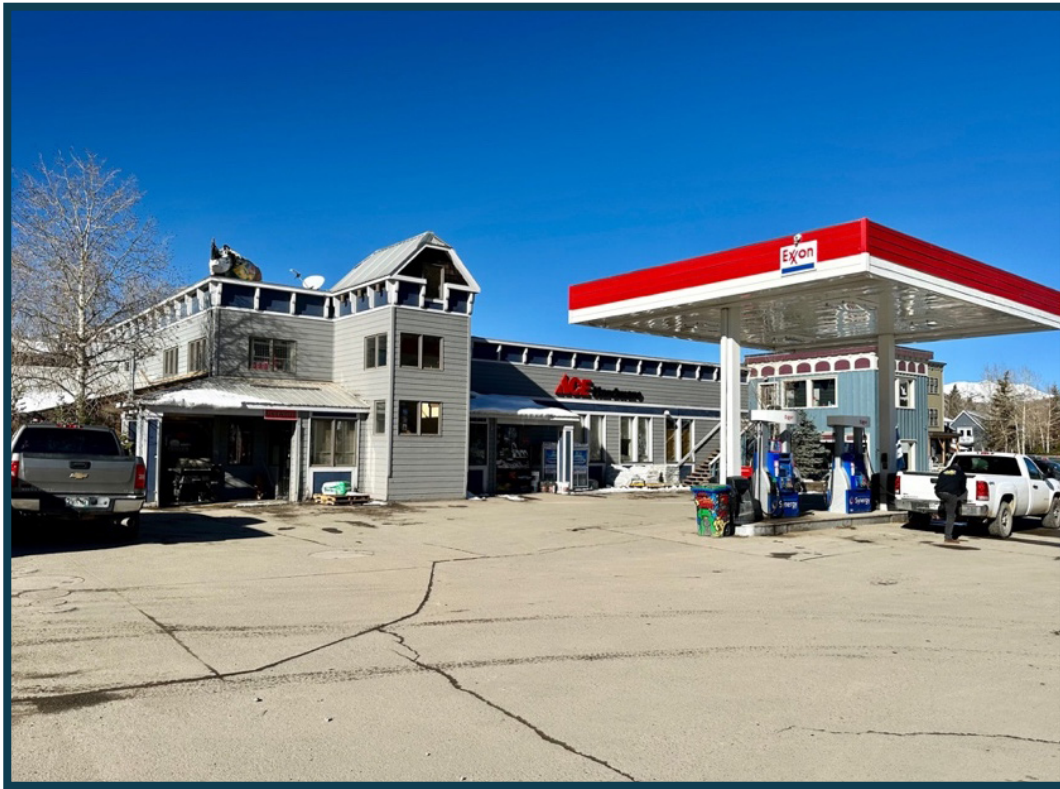
The wood-frame commercial building at **601-607 Sixth St.** stands on a prominent lot at the entrance to Crested Butte. It houses a hardware store and offices, with a fueling station out front. The building was constructed in 1970 and expanded in 1978. Architectural features include weatherboard and board-and-batten siding, a front two-story tower with a clipped gabled roof, brackets and dentil banding along the cornice, and a flat roof. It was designed to present a faux Victorian appearance.

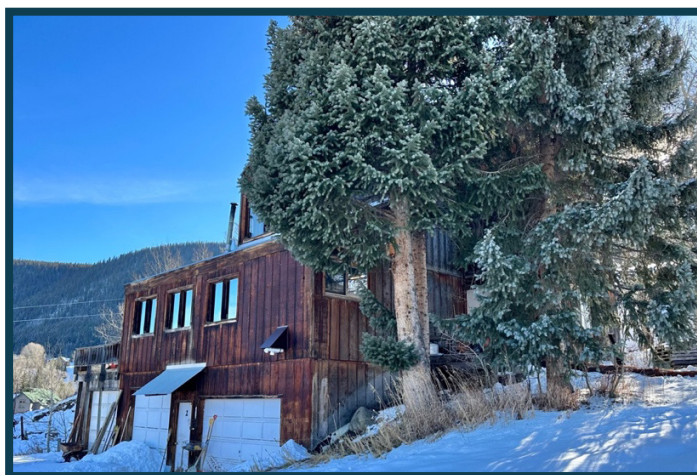
**2 Maroon Ave.** - This wood-frame Contemporary Style house was built in 1970. Its architectural features include board-and-batten siding, sliding windows, and a two-level shed roof. Built on a slope, the garages are tucked under the building.

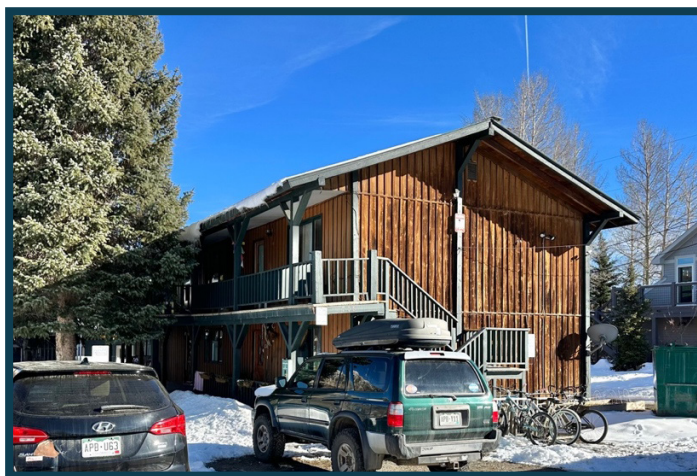
**706 Gothic Ave.** - This two-story wood-frame Contemporary Style apartment building was built in 1970. Its architectural features include board-and-batten siding, a two-story balcony on one side that is supported by posts with brackets, doors with cross-bracing and diamond lights, sets of fixed windows flanked by what appear to be casement windows, and a medium-sloped gabled roof.

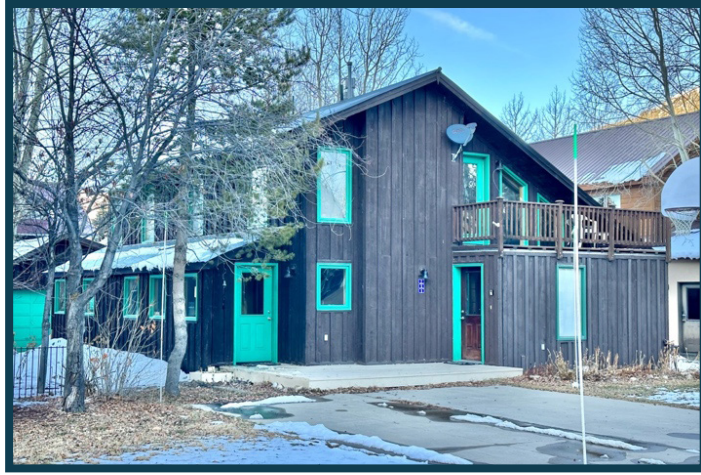
**711 Elk Ave.** – This Contemporary Style wood-frame house was built in 1971. Architectural features include its board-and-batten siding, variety of window types, a balcony with an open rail, and a medium-sloped gabled roof.

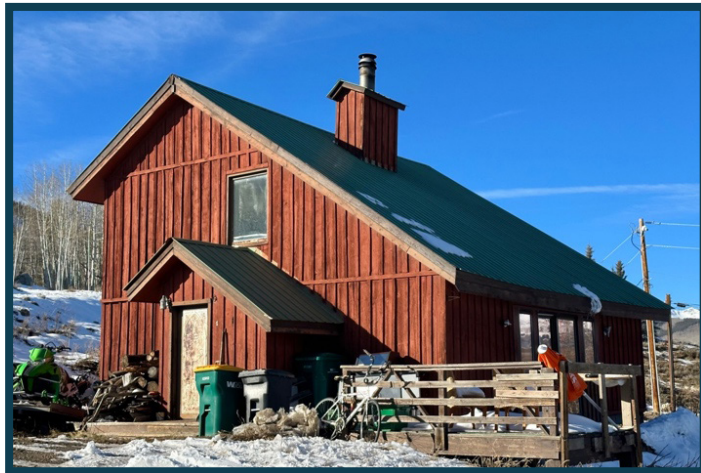
**1 Maroon Ave.** – This Contemporary Style wood-frame house was built in 1972. Its architectural features include board-and-batten siding, fixed and possibly casement windows, a steeply-pitched saltbox roof with a boxed chimney, and a projecting entry vestibule with a matching saltbox roof.

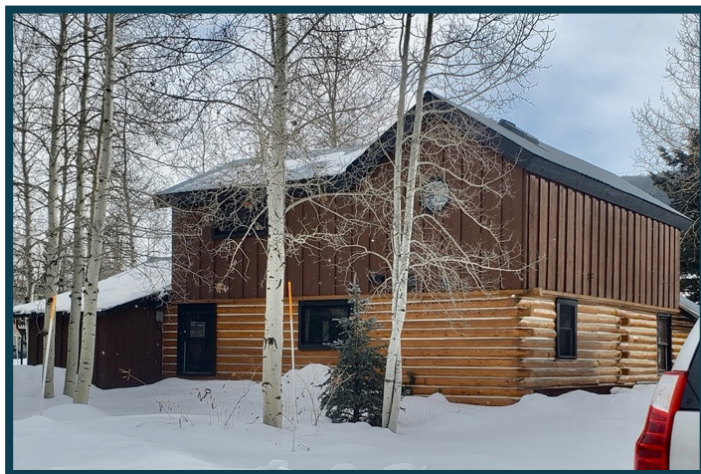
**30 Teocalli Ave.** – This Contemporary Style combination log and wood-frame house was built in 1972. Rather than being hewn, it appears that the logs on the lower floor were milled. The upper walls are finished with board-and-batten siding. Windows are fixed or multi-light, some trapezoidal in shape. The roof consists of intersecting gables.

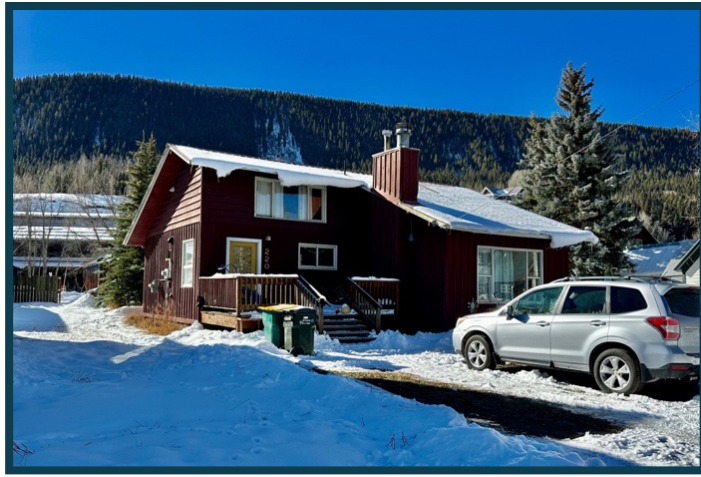
**220 Whiterock Ave.** – This Contemporary Style wood-frame house was built in 1972. Its architectural features include board-and-batten wall cladding with horizontal boards on the second story, a front entry deck, fixed windows with side lights, a boxed chimney, and a side-gabled saltbox roof.

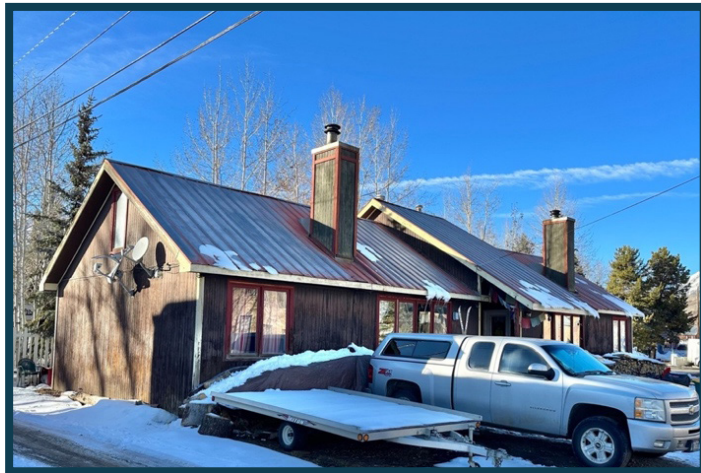
**430 Maroon Ave.** – This Contemporary Style wood-frame house was built in 1972. Its architectural features include vertical exterior wall paneling, pairs and bands of large fixed or casement windows on the façade, a side-gabled roof, and two boxed chimneys.

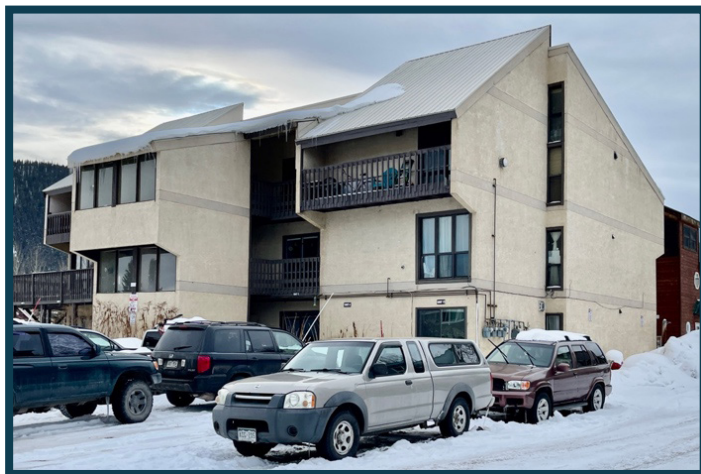
**117 Seventh St.** – This Contemporary Style apartment building was built in 1973. Its architectural features include its three-story height with cantilevered upper floors, stuccoed exterior walls, bands of windows along with tall narrow windows, balconies, and broken gabled roof forms with varying slopes.

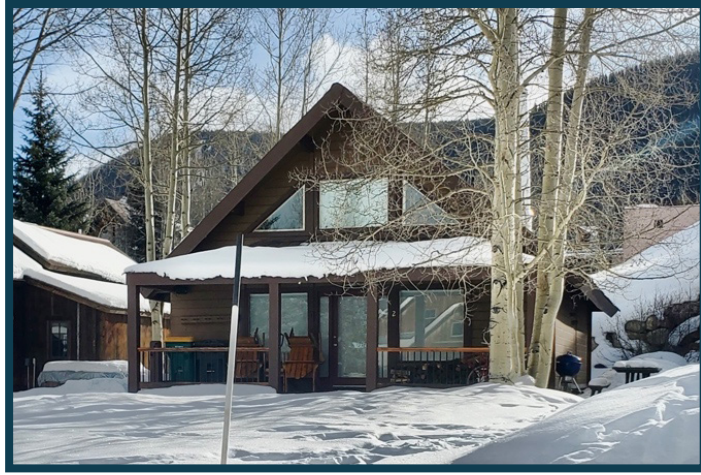
**2 Teocalli Ave.** – This Contemporary Style residence was built in 1973. Although its basic form may look like a throwback to an earlier era, the house features large fixed picture windows and a glass door with sidelights on the main floor along with rectangular and triangular windows in the gable end wall. These features distinguish it from historic buildings of prior years.

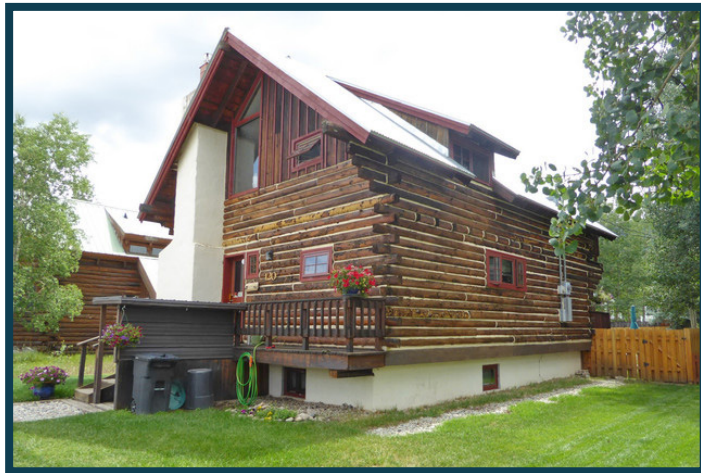
**120 Teocalli Ave.** – This Contemporary Style log residence was built in 1973. A raised foundation encloses a basement and supports the rustic milled log structure above. Board-and-batten siding was employed in the gable end walls. Also present on the building are a deck, stuccoed exterior wall chimney, shed dormer, and a variety of windows that include rectangular and triangular shapes in the gable end wall.

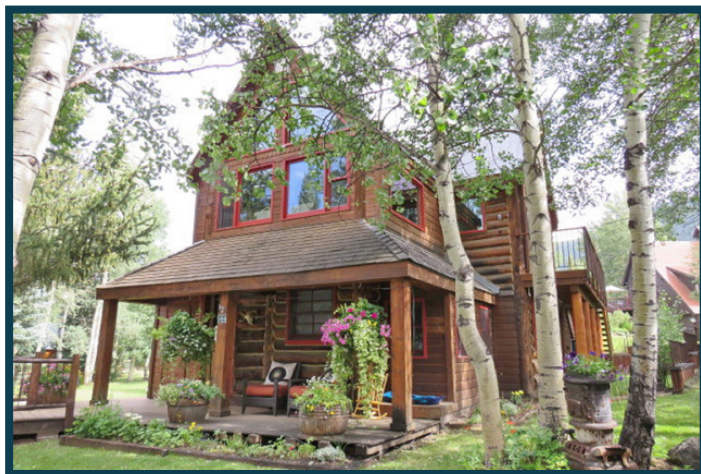
**14 Gothic Ave.** – This Contemporary Style log residence was built in 1973. Although it exhibits features of an older style, it appears to be a wood-frame building whose exterior walls are clad in log siding. Architectural elements include its tall height, open porch and a deck, a steeply-pitched roof, and multiple windows in the front gable end wall.

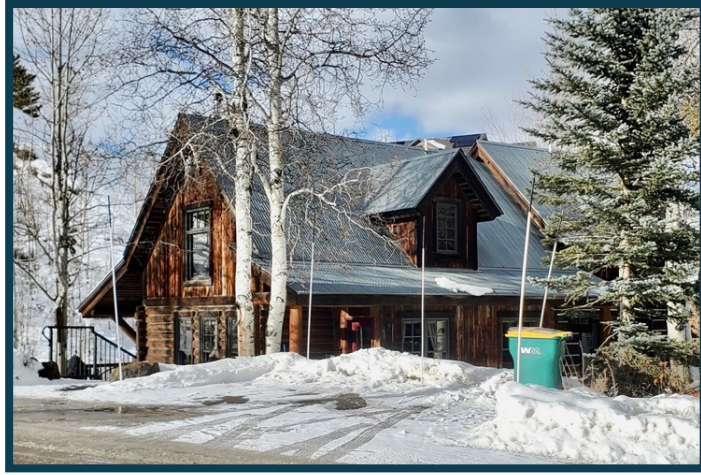
**15 Whiterock Ave.** – This Contemporary Style log residence was built in 1973. Its architectural features include log construction along with board-and-batten siding in the gable end walls. It also has steeply-pitched roof slopes with eave extensions, gabled dormers, a combination of window types, and corrugated metal panels on the roof.

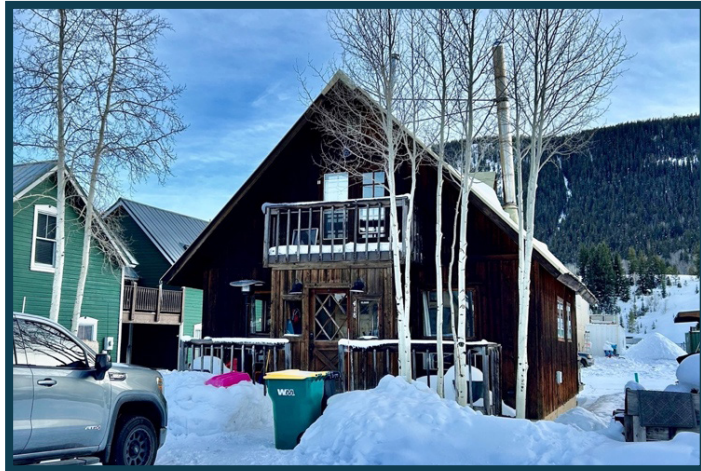
**418 Whiterock Ave.** – This Contemporary Style Chalet residence was built in 1973. Its architectural features include board-and-batten siding, balconies on both levels, a front door with diamond patterns in the lower panel and upper lights, and a steeply-pitched roof.

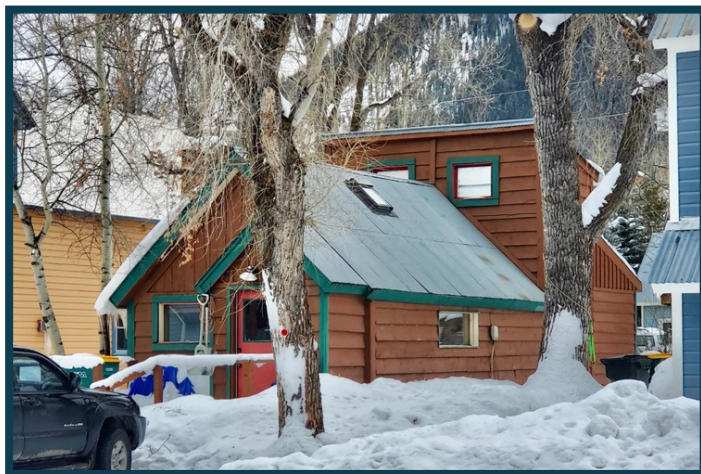
**118 Sopris Ave.** – This simple Contemporary Style residence was built in 1974. Its architectural features include wide clapboard siding, fixed windows, and a steeply-pitched gabled roof with a taller intersecting shed roof.

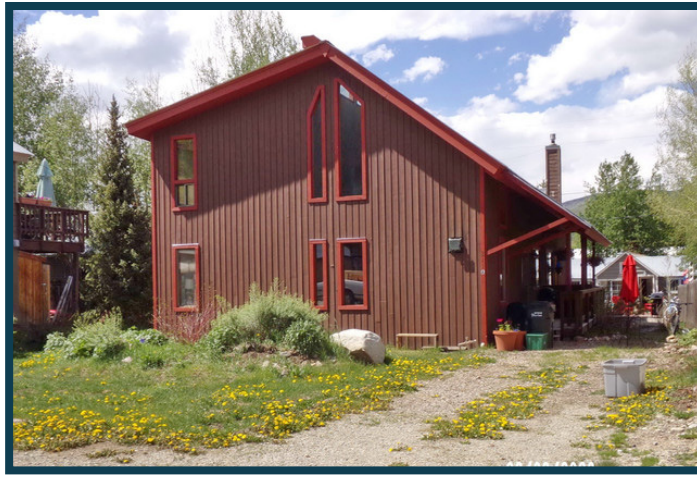
**211 Gothic Ave.** – This Contemporary Style residence was built in 1974. Its architectural features include its two-story height, extensive use of board-and-batten siding, and saltbox roof with a boxed chimney and eave extension. Many of the tall rectangular windows are fixed and some have diagonal tops.

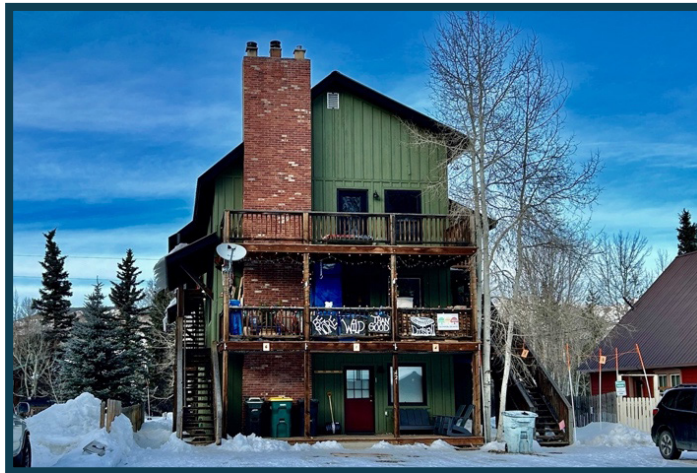
**421 Whiterock Ave.** – This Contemporary Style residence was built in 1974. Its architectural features include its tall three-story height, open decks, large brick exterior wall chimney, long flights of stairs, board-and-batten siding, and saltbox roof.

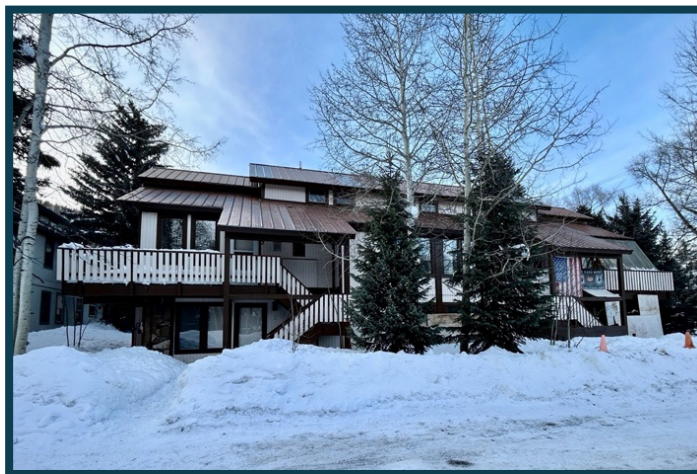
**28 Whiterock Ave.** – This Contemporary Style residential duplex was built in 1974. Its architectural features include vertical wood siding (possibly board-and-batten), variety of windows types and sizes, extensive stairs and decks, and multiple roof levels clad in standing seam metal panels.

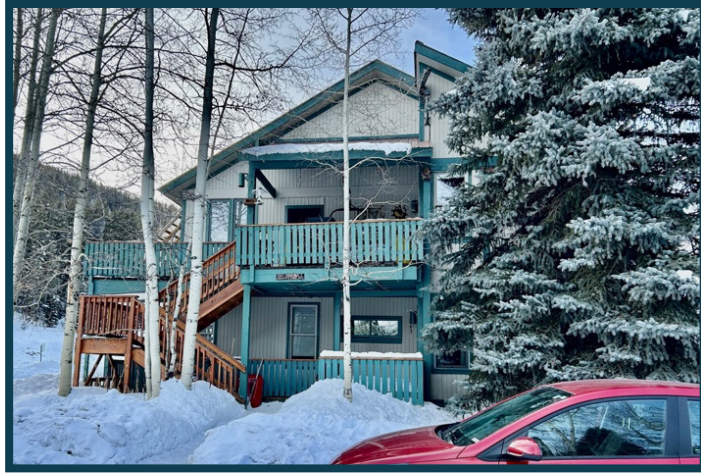
**32 Whiterock Ave.** – This Contemporary Style residence was built in 1974. Its architectural features include vertical siding, open stairs and decks, a variety of window types and sizes, and a combination gabled and shed roof.

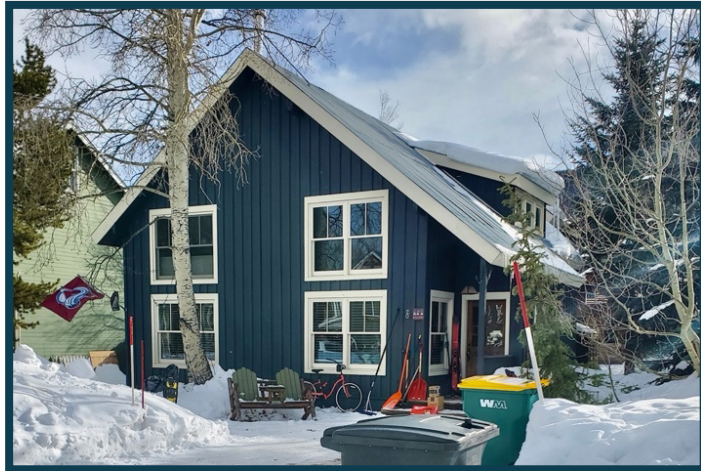
**20 Teocalli Ave.** – This Contemporary Style residence was built in 1975. Although it hints at a style of an earlier era, the building is modern with its board-and-batten siding, two-over-one double-hung sash windows, cutaway corner porch, and steeply-sloped roof with a shed dormer. This is a good example of a building that is contemporary but reflects the town's historic environment.

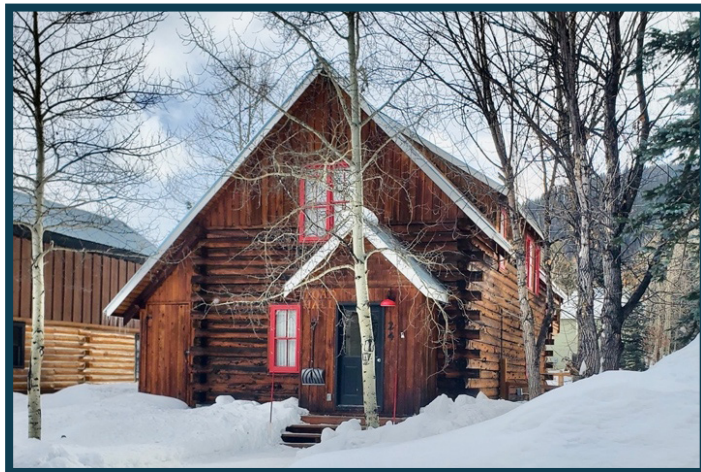
**24 Teocalli Ave.** – This Contemporary Style rustic log residence was built in 1975. Its architectural features include its construction using what appear to be milled logs that extend beyond the corners, a projecting entry vestibule, double-hung windows, a wood-frame extension on one side of the building, and a steeply-pitched roof with a wall dormer.

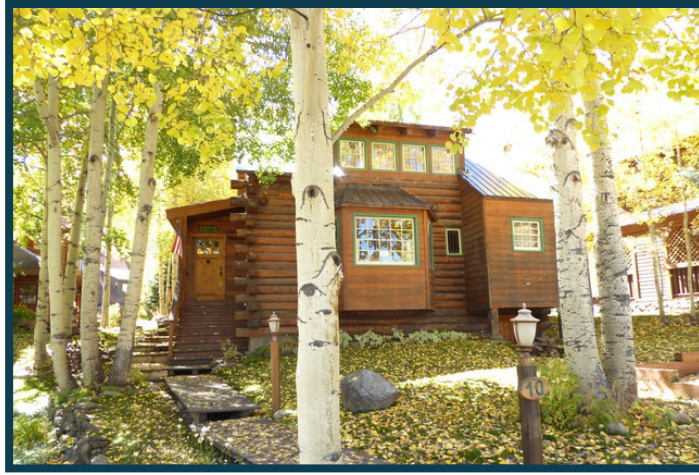
**10 Gothic Ave.** – This Contemporary Style log residence was built in 1975. Its architectural features include its construction using what appear to be milled logs whose ends extend beyond the corners, wood-frame extensions to the sides and above, a squared bay window, multi-light windows, and roof areas at different levels.

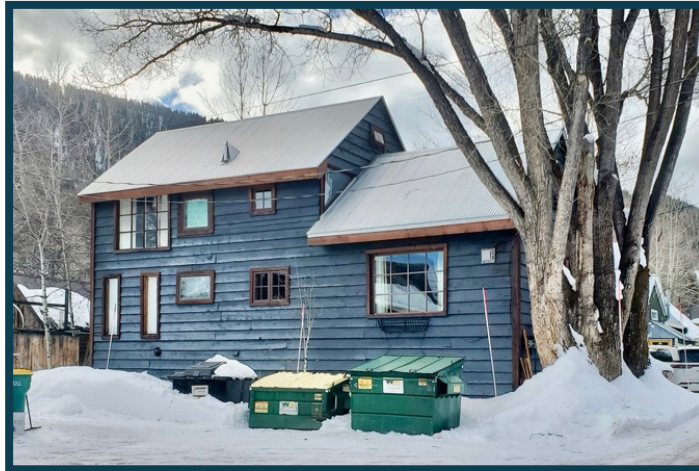
**125 Whiterock Ave.** – This simple Contemporary Style residence was built in 1975. Its architectural features include clapboard siding, a variety of window types and sizes, and gabled roofs at two levels.
