# Appendix

## Bibliography

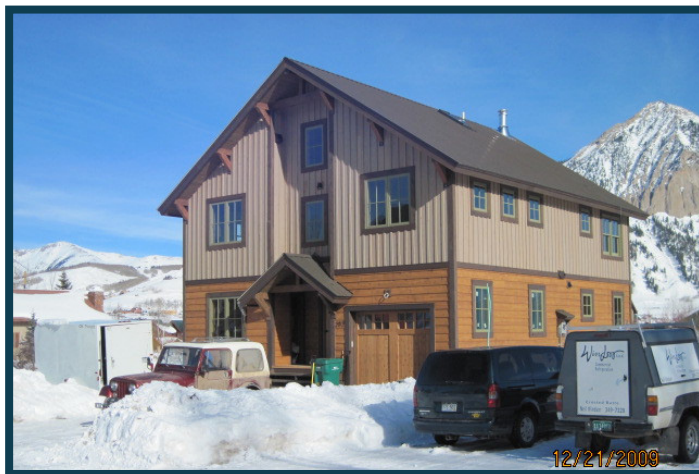
**202 Third St.** – This Contemporary Style residence was built in 1976 but might have been remodeled in more recent years. Its architectural features include clapboard siding on the main floor with board-and-batten siding above, a variety of multi-light windows, a centered main entrance with a gabled hood above, a garage door, and a gabled roof with brackets at the eaves.

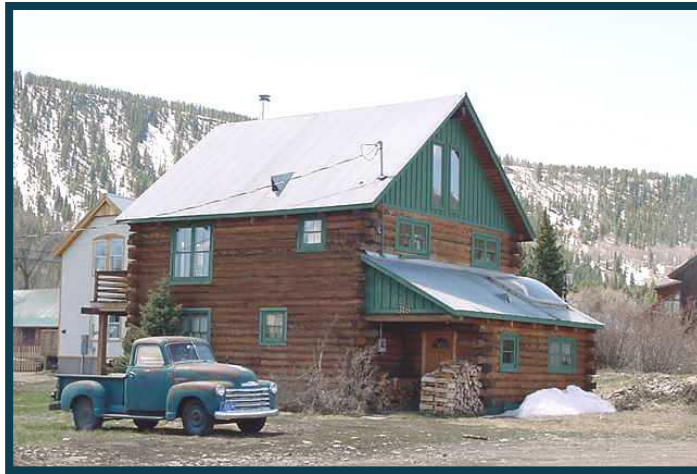
**318 Gothic Ave.** – This Contemporary Style log residence was built in 1976. Its architectural features include its two-story construction with what appear to be milled logs that extend beyond the corners, along with double-hung windows, board-and-batten siding and tall fixed windows in the gable end wall, a log projection at one end and a balcony at the other, and a steeply-pitched gabled roof.

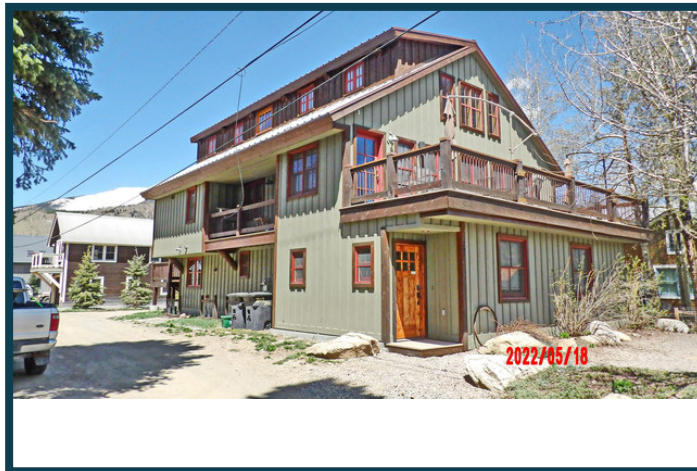
**207 Third St.** – This Contemporary Style residence was built in 1976. Its architectural features include board-and-batten siding, double-hung windows, second-floor decks with open rails, and a steeply-pitched gabled roof with a long shed dormer just below the peak.

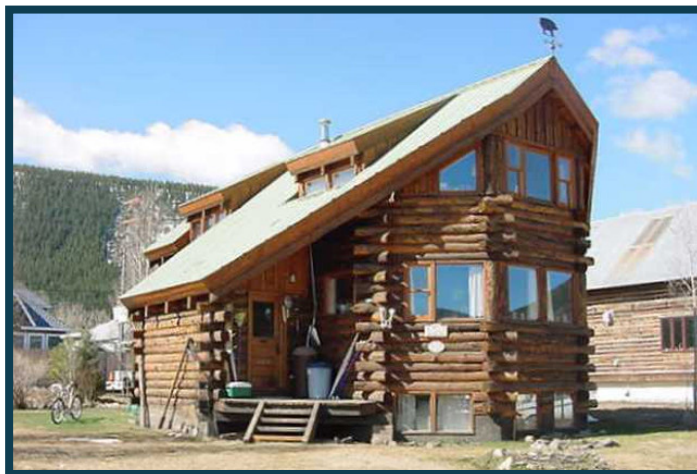
**122 Teocalli Ave.** – This Contemporary Style log residence was built in 1977. Its architectural features include its construction with what appear to be peeled logs that extend beyond the corners, its unusual three-sided front wall that extends to a height of 2½ stories, a variety of window types and sizes, the open cutaway front porch, and its steeply-pitched roof with shed dormers.

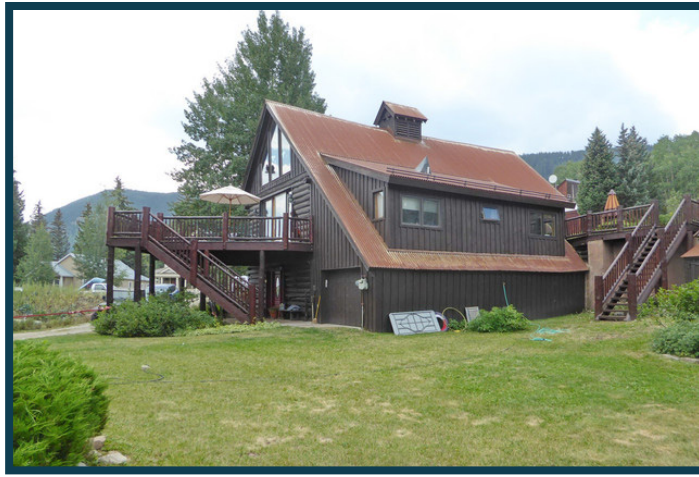
**17 Maroon Ave.** – This Contemporary Style residence was reportedly completed in 1977. Its architectural features include what appears to be wood-frame construction with a combination of log and board-and-batten siding, a variety of window sizes and types, large fixed windows with diagonal tops in the gable end wall, open decks, and a steeply-pitched roof with a large shed dormer and gabled ventilator along the ridgeline.

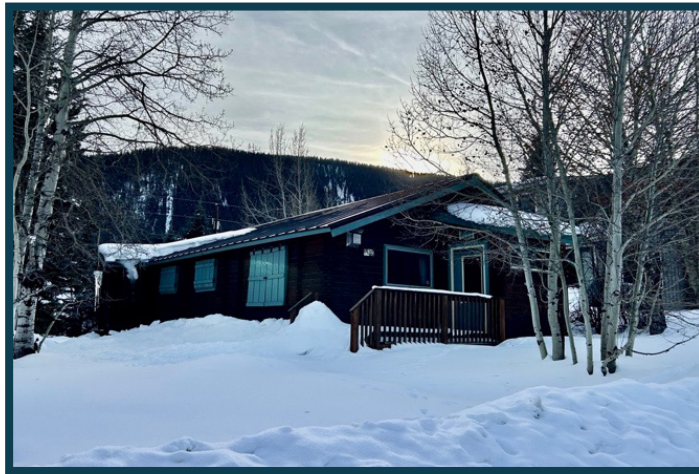
**420 Sopris Ave.** – This Contemporary Style residence was built in 1977. It appears to be of either log or wood-frame construction. Its architectural features include a front entry deck, windows of various sizes along with exterior wood shutters, and a low-pitched roof.

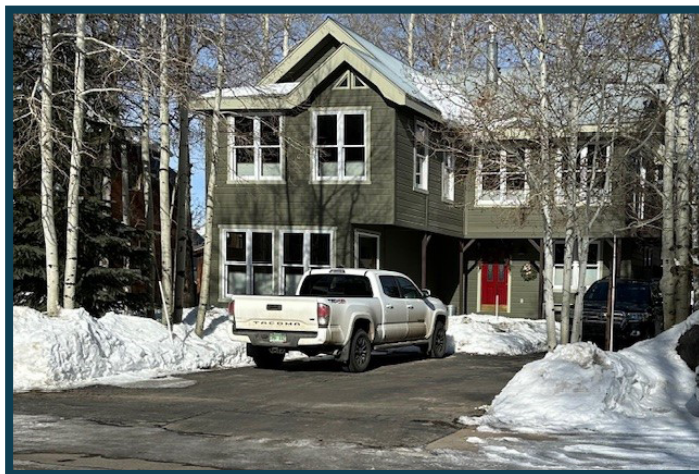
**705 Belleview Ave.** – This Contemporary Style residence was built in 1977. Its architectural features include horizontal weatherboard siding, multiple pairs of double-hung windows, a cantilevered upper floor supported by posts with knee braces, and a roof consisting of intersecting gables.

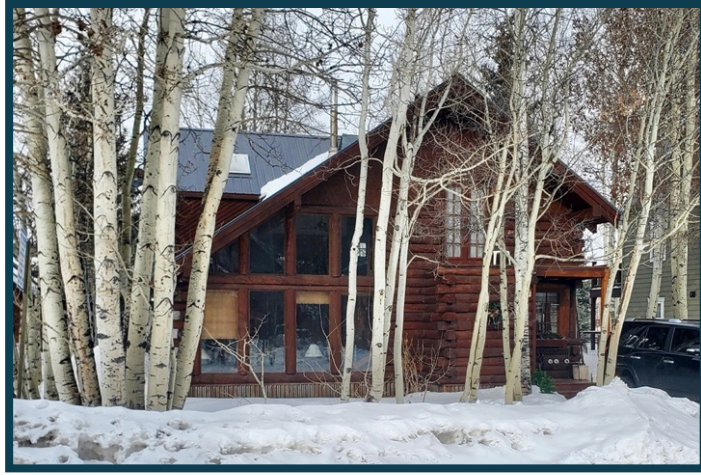
**27 Teocalli Ave.** – This Contemporary Style log residence was built in 1978. Its architectural features include milled log construction with the ends projecting beyond the corners, bands of large fixed windows, and a saltbox roof with intersecting gables.

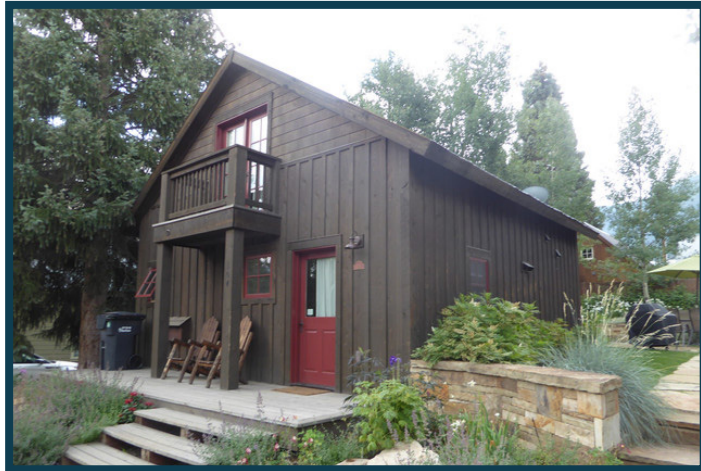
**104 Maroon Ave.** – This simple Contemporary Style residence was built in 1978. Its architectural details include board-and-batten siding, a deck with a small balcony above, a variety of multi-light windows, and a front-gabled roof.

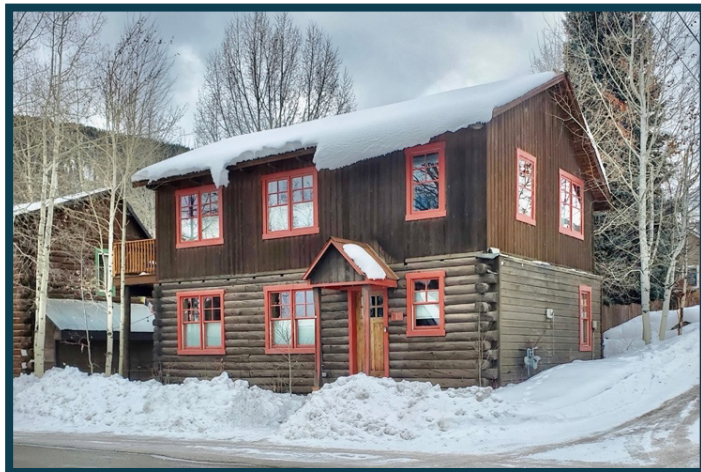
**415 Fifth St.** – This Contemporary Style log residence was built in 1978. Its architectural features include peeled log construction on the main floor with wood-frame construction above, vertical siding on the upper walls (possibly board-and-batten), singles and pairs of double-hung sash windows, a small hood above the main entry, and a side-gabled roof.

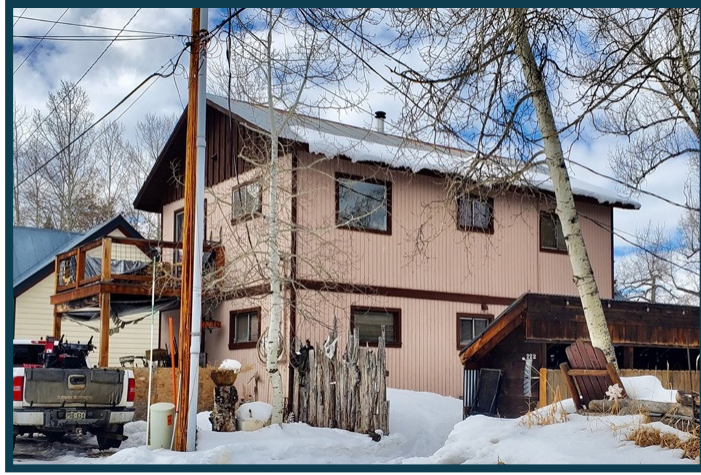
**218 Sopris Ave.** – This simple Contemporary Style residence along the alley was built in 1978. Its architectural details include vertical wood siding, a combination of fixed and two-light windows, a deck and balcony, board-and-batten siding in the gable end walls, and a medium-pitched gabled roof.

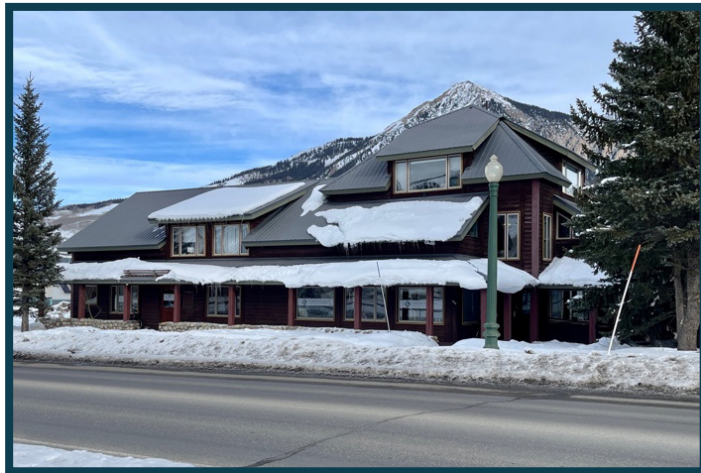
**214 Sixth St.** – This Contemporary Style 2½-story office building was built in 1978. Its architectural details include horizontal siding, a variety of windows sizes and types (including fixed picture windows, narrow casements, and central fixed windows with flanking casements), a covered walkway, gabled and pyramidal roof forms, and shed dormers.

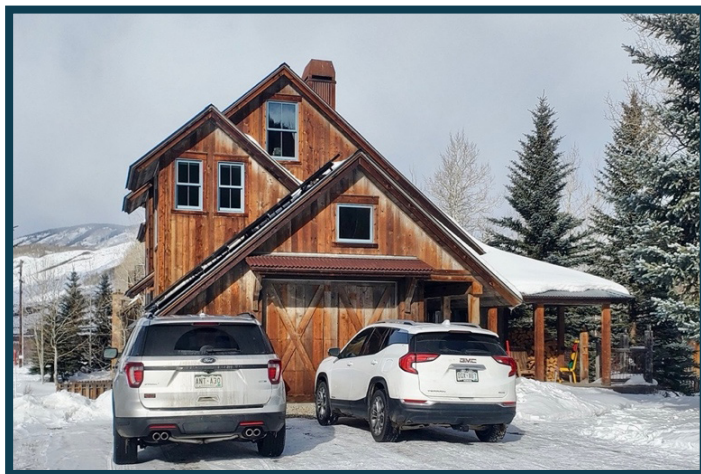
**1 Teocalli Ave.** – This Contemporary Style rustic residence was built in 1979. Its architectural features include vertical natural wood siding, an open porch supported by log posts, an x-braced vertical board garage door with a corrugated hood above, saltbox roofs at three levels, and a boxed chimney. These features give the building the appearance of a mining structure.

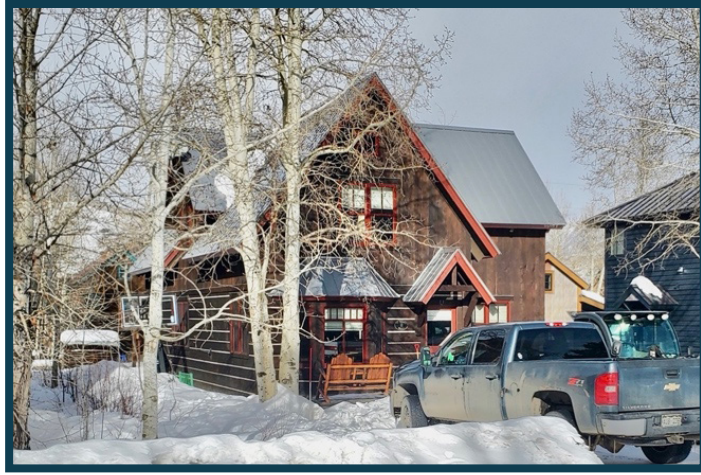
**13 Teocalli Ave.** – This Contemporary Style log residence was built in 1979. Its architectural features include squared logs with white chinking on the main floor with wood-frame construction above and to one side, a front bay window, a gabled hood over the main entrance, double-hung windows, and a steeply-pitched roof consisting of intersecting gables.

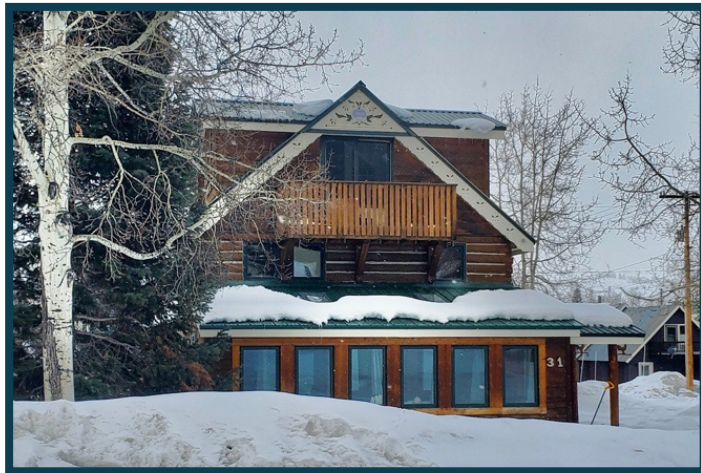
**31 Gothic Ave.** – This Contemporary Style Chalet log residence was built in 1979. Its architectural features include its construction with logs on the lower half with wood-frame construction above and to the front. The front projection is lined with a band of six fixed rectangular windows, with a variety of windows and doors appearing on the rest of the building. The upper area of the house features Chalet detailing, including a centered balcony with a wood rail, and gable fascia and a bargeboard above that are decorated with floral patterns.

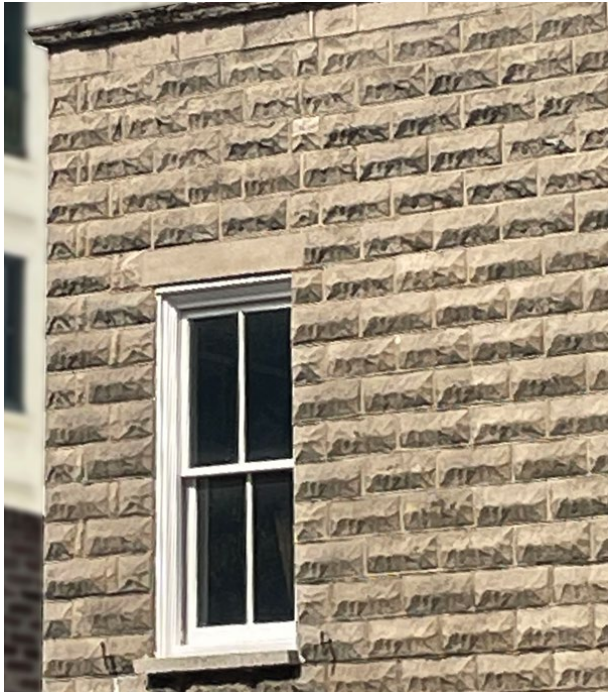
Figure 2a: Casting concrete blocks to mimic quarried stone was a popular late 19th- to mid 20th-century technique. Concrete masonry units could be completed by local craftsman, saving time and shipping costs. Photo: John Sandor, NPS.

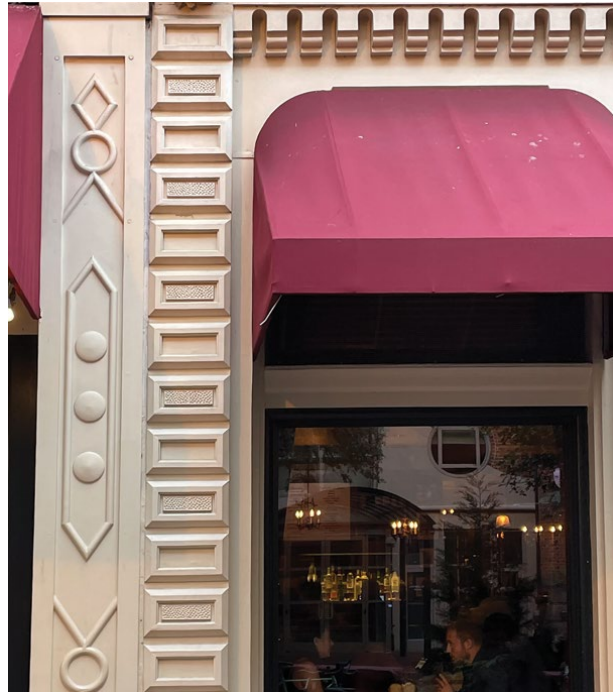
Figure 2b: The 19th century also produced a variety of metal products used to imitate other materials. Across the country, cast iron was used in storefronts to imitate stone. Photo: John Sandor, NPS.

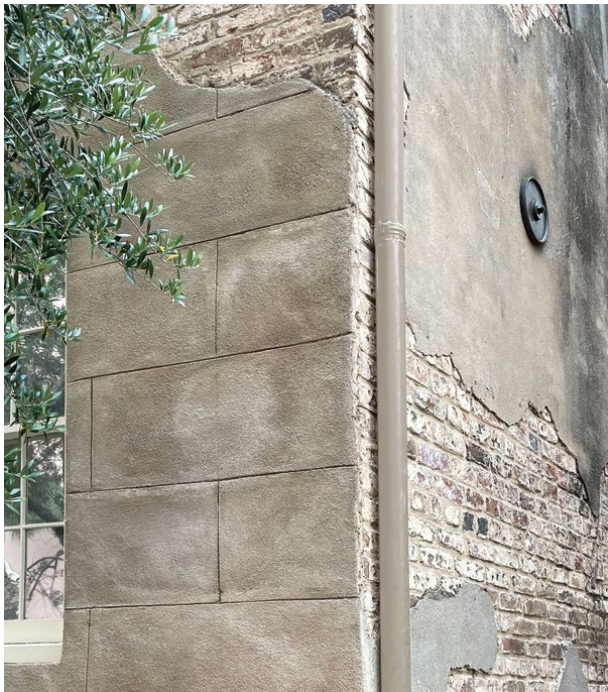
Figure 2c: Stucco has been used to imitate a number of building materials for many centuries. Seen here, stucco was applied to a brick structure and scored to represent a stone façade. Photo: John Sandor, NPS.

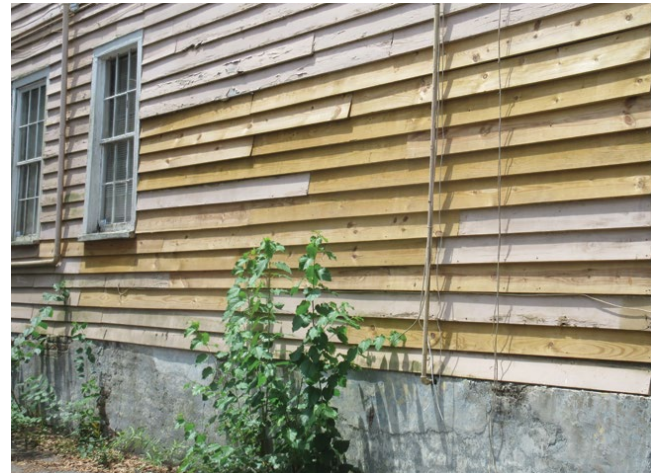
Figure 3: Incremental repair is best done using in-kind material to minimize differences in the performance characteristics that could negatively affect the overall assembly. Photo: NPS.

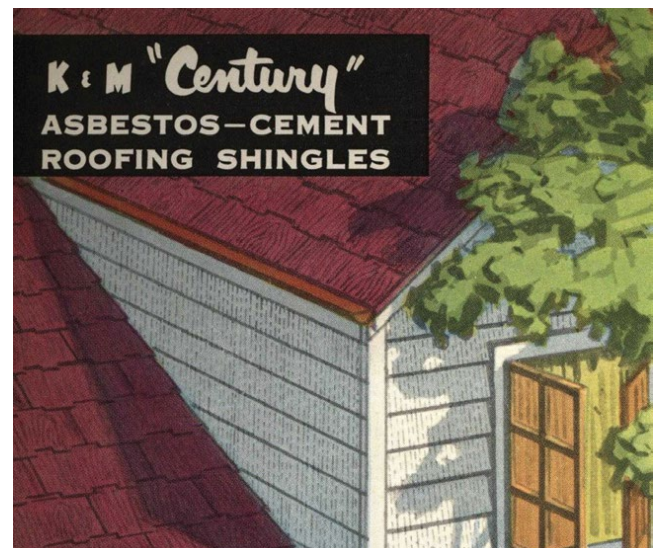
Figure 4. While occasionally used to imitate other materials such as wood or slate shingle, many asbestos shingles and siding materials had their own distinct shape and profile. No longer manufactured today, alternative materials must be found to replace these materials when they are distinctive features on a historic structure. Drawing: Association for Preservation Technology, Building Technology Heritage Library.

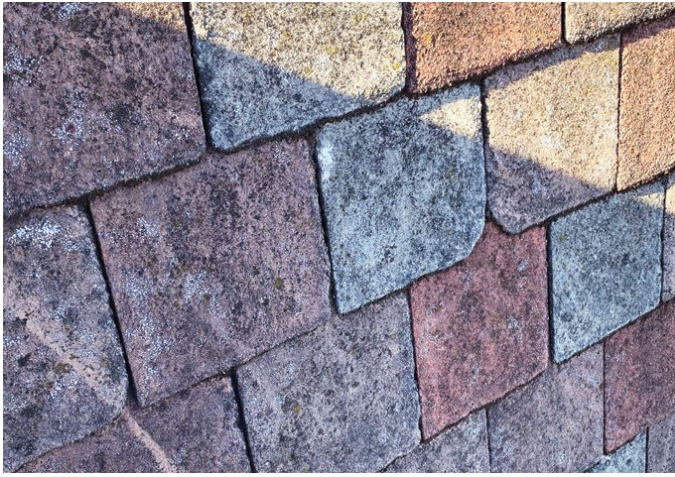
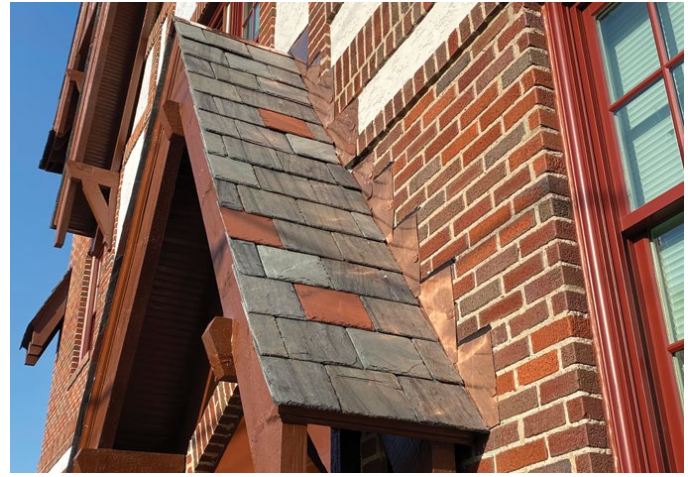
*Figure 5. (Left) Asbestos shingles were often used as a substitute for traditional slate roof shingles. The historic asbestos roof on this rehabilitation project had reached the end of its lifespan and required complete replacement. (Right) Given the limited replacement materials available to match the historic asbestos shingles, utilizing natural slate was determined to be the best visual match for the original shingles and design intent in this instance. Photos: Crosskey Architects.*

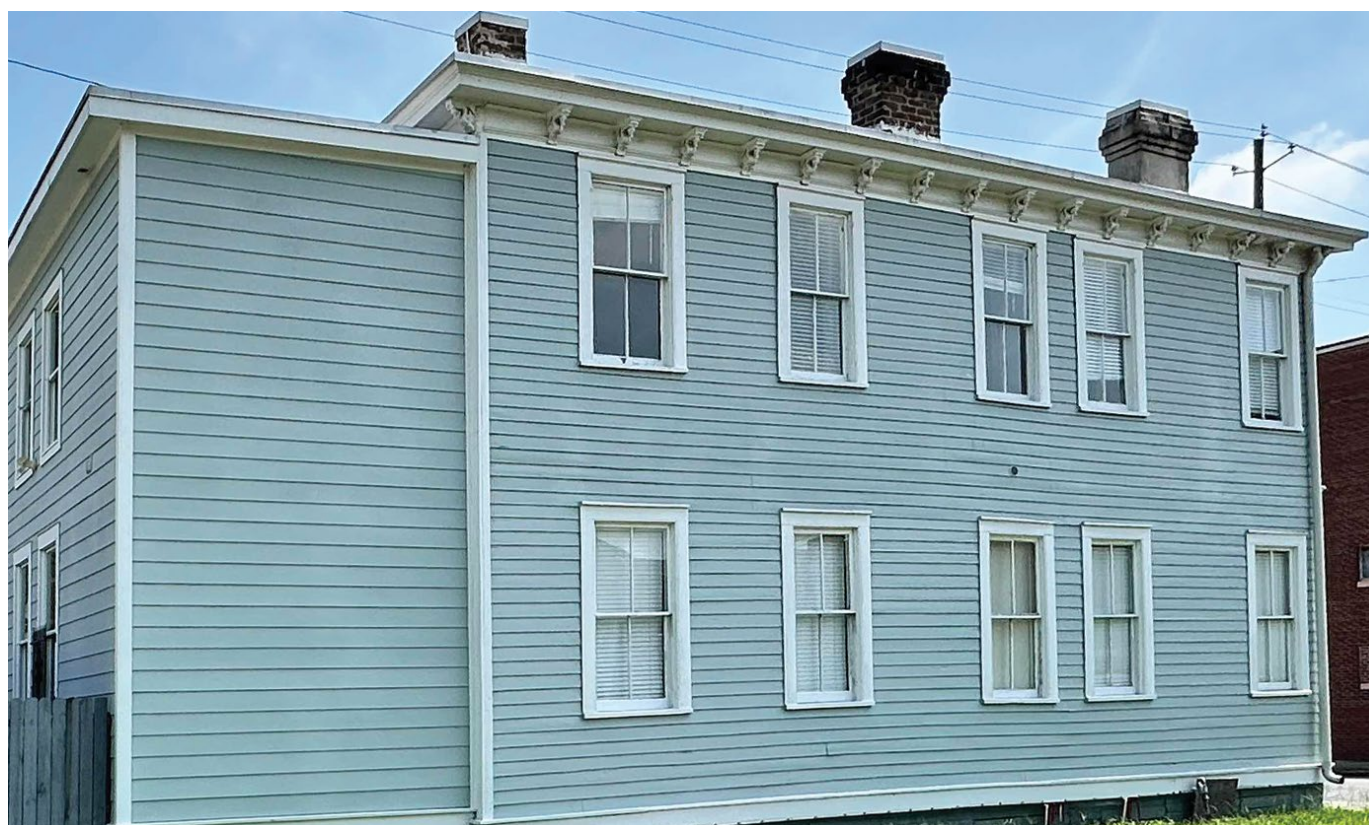
*Figure 7. A new addition replaced non-historic construction on the rear elevation of this building. Fiber cement gives the addition a compatible appearance without replicating the exposure for thickness of the historic siding. Photo: Ward Architecture + Preservation.*

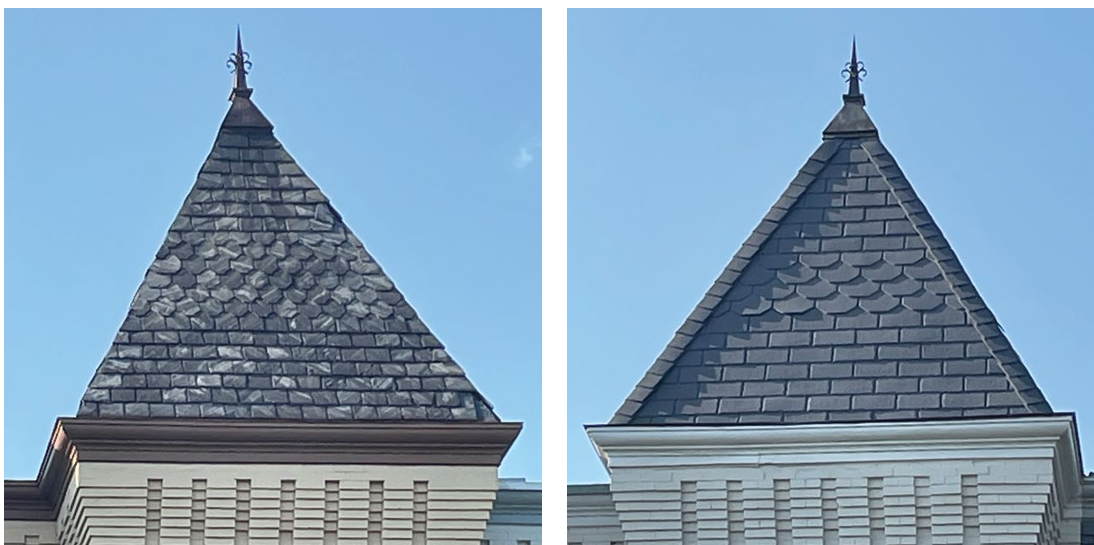
*Figure 10. Polymer slates offer a choice of shapes but not sizes, limiting their ability to achieve a good visual match for some historic slate. With the size of the polymer slates (right) being nearly twice that of the historic slates (left), the scale of the entire feature is incompatibly altered. The molded edges of this material, which contribute to its ability to replicate slate, would be lost if each shingle was resized by cutting. Photo: John Sandor, NPS.*

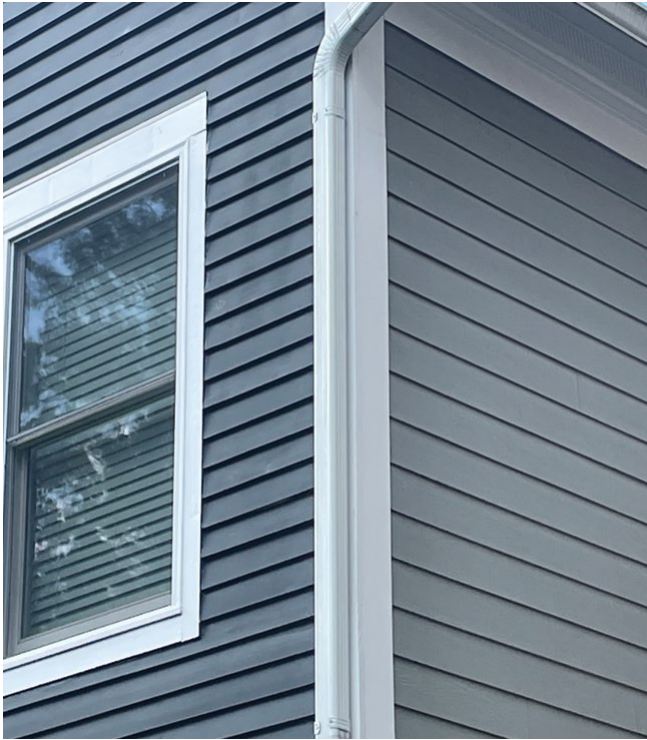
*Figure 11. The thickness of the wood siding on the front (left) creates a deeper shadow line than is achieved with the fiber cement siding used on the side (right) elevation. While the exposure can be adjusted, fiber cement siding is not available in a matching thickness. Photo: John Sandor, NPS.*

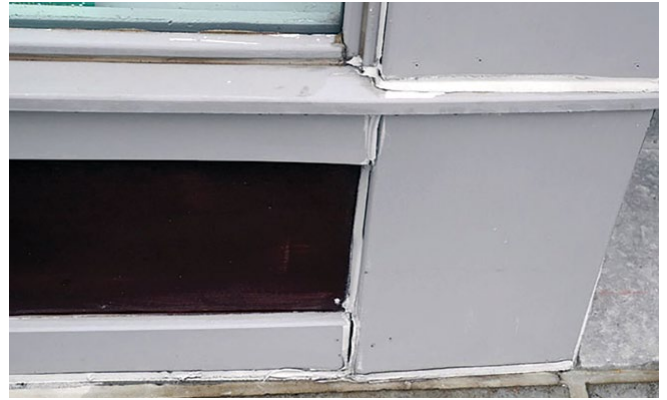
*Figure 12. Cellulose composite materials, like wood, expand and contract with moisture. Here it was used to reconstruct a missing storefront. Unlike solid wood that is dimensionally stable parallel to the grain, this composite moves equally in all dimensions, resulting in gaps that were not adequately anticipated in the design. Photo: John Sandor, NPS.*

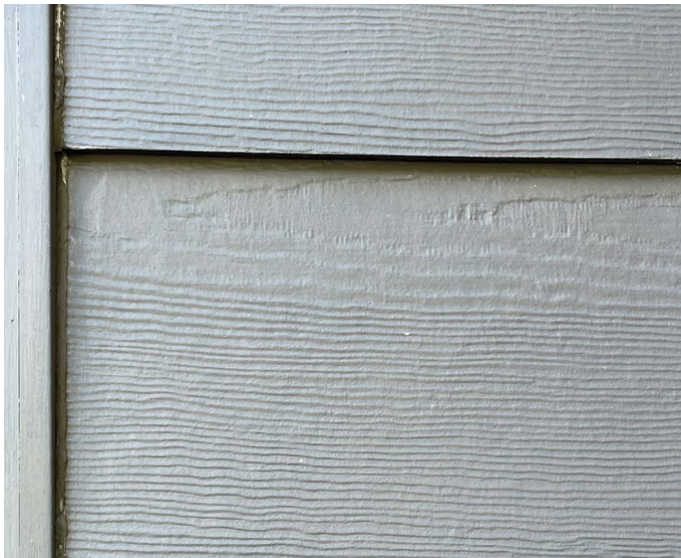
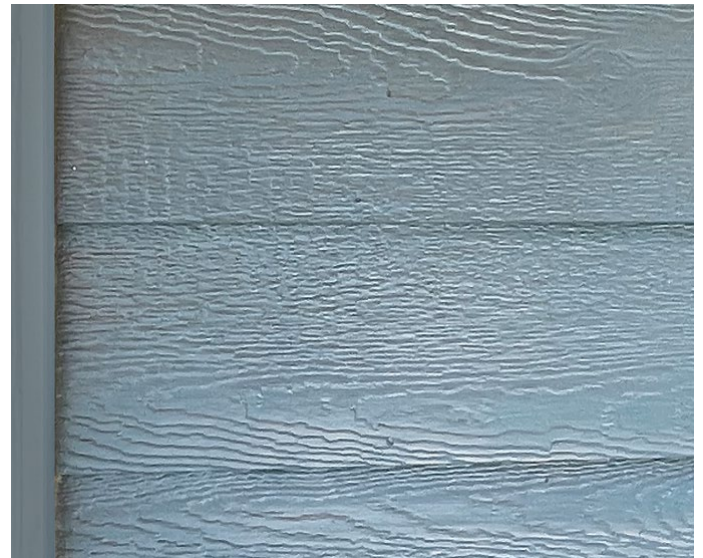
Figure 14. Surface texture is an important aspect in matching the appearance of a historic material, especially when a material is viewed at close range. As seen in these two images, many of the substitute materials produced for siding and trim have an embossed wood grain, making them incompatible for replacing historic wood that was typically planed to a smooth surface. Some substitute products are available with a smooth surface as well. Photos: John Sandor, NPS.

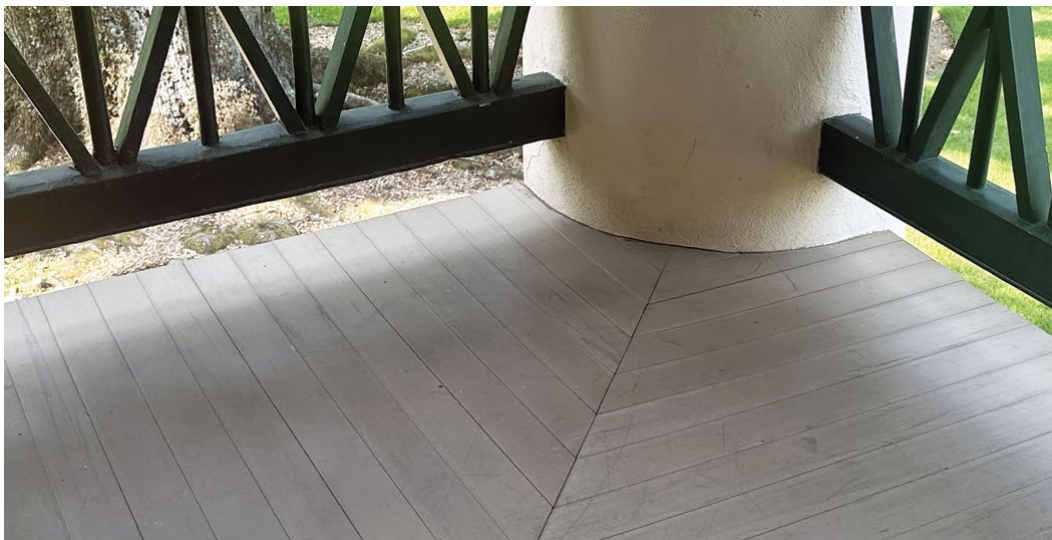
*Figure 15. Tongue-and-groove porch flooring is manufactured in several different substitute materials. Each type has different properties, though most are more moisture-resistant than wood. The prefinished product shown can be painted when worn, but repainting is not recommended for some product choices. Photo: Oak Alley Foundation.*

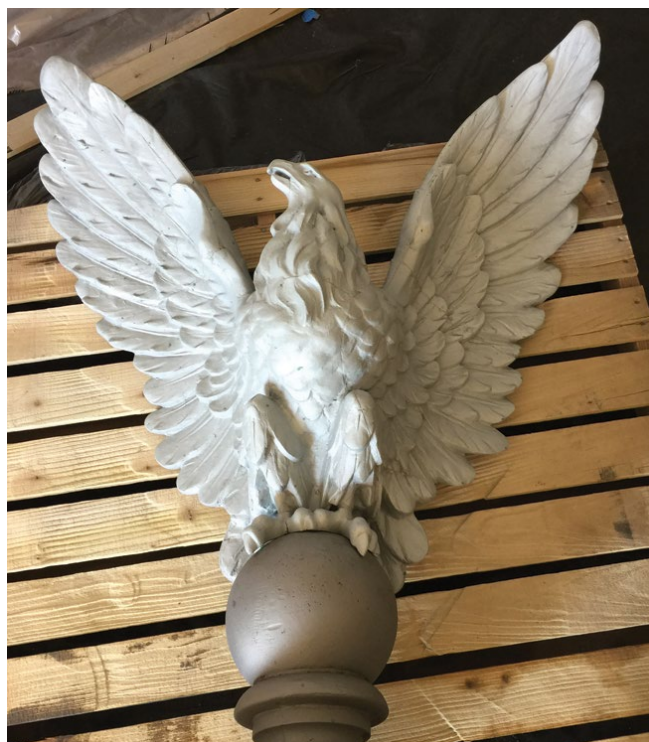
*Figure 16. Aluminum is a highly corrosion-resistant metal that is commonly used as a substitute material for cast iron. Aluminum can be a more affordable and lightweight alternative to cast iron that retains a similar texture, shape, and maintenance cycle. Photo: NPS.*

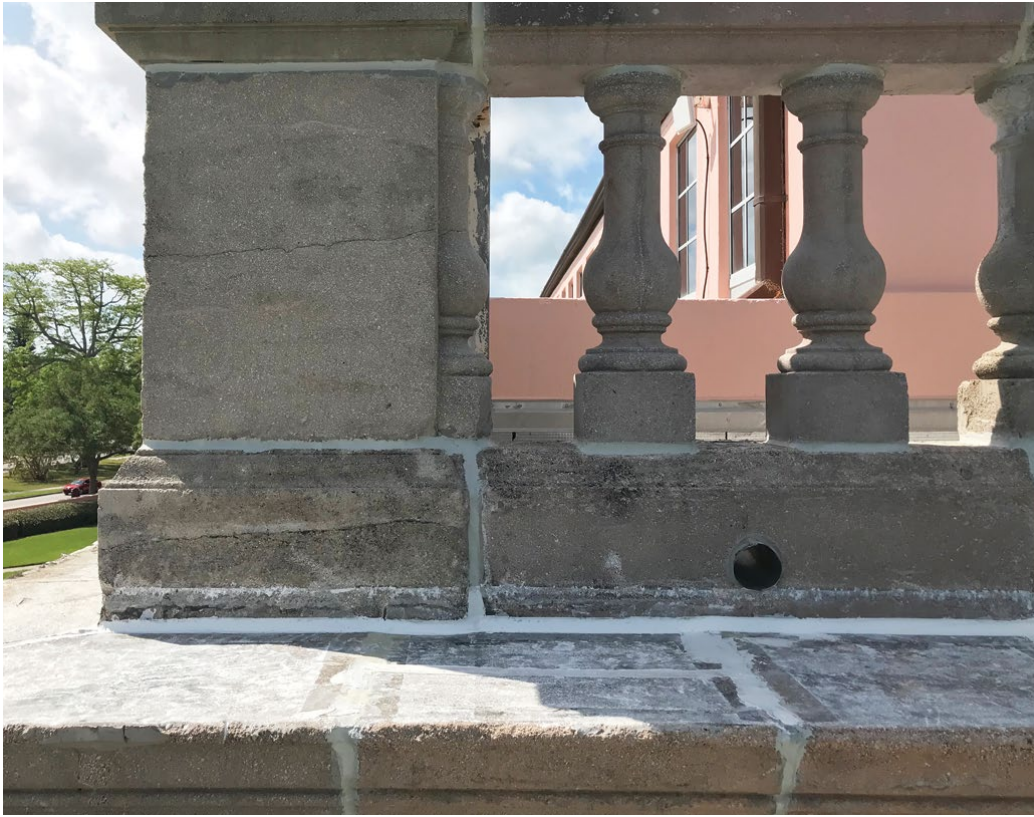
*Figure 17. The balustrade consists of multiple prior campaigns of using cast stone to replace the natural stone. The effective match for the surface texture and color of the original stone allowed individual elements to be incrementally replaced only when they had failed, thus retaining the maximum amount of original material as long as possible. Photo: EverGreene Architectural Arts.*

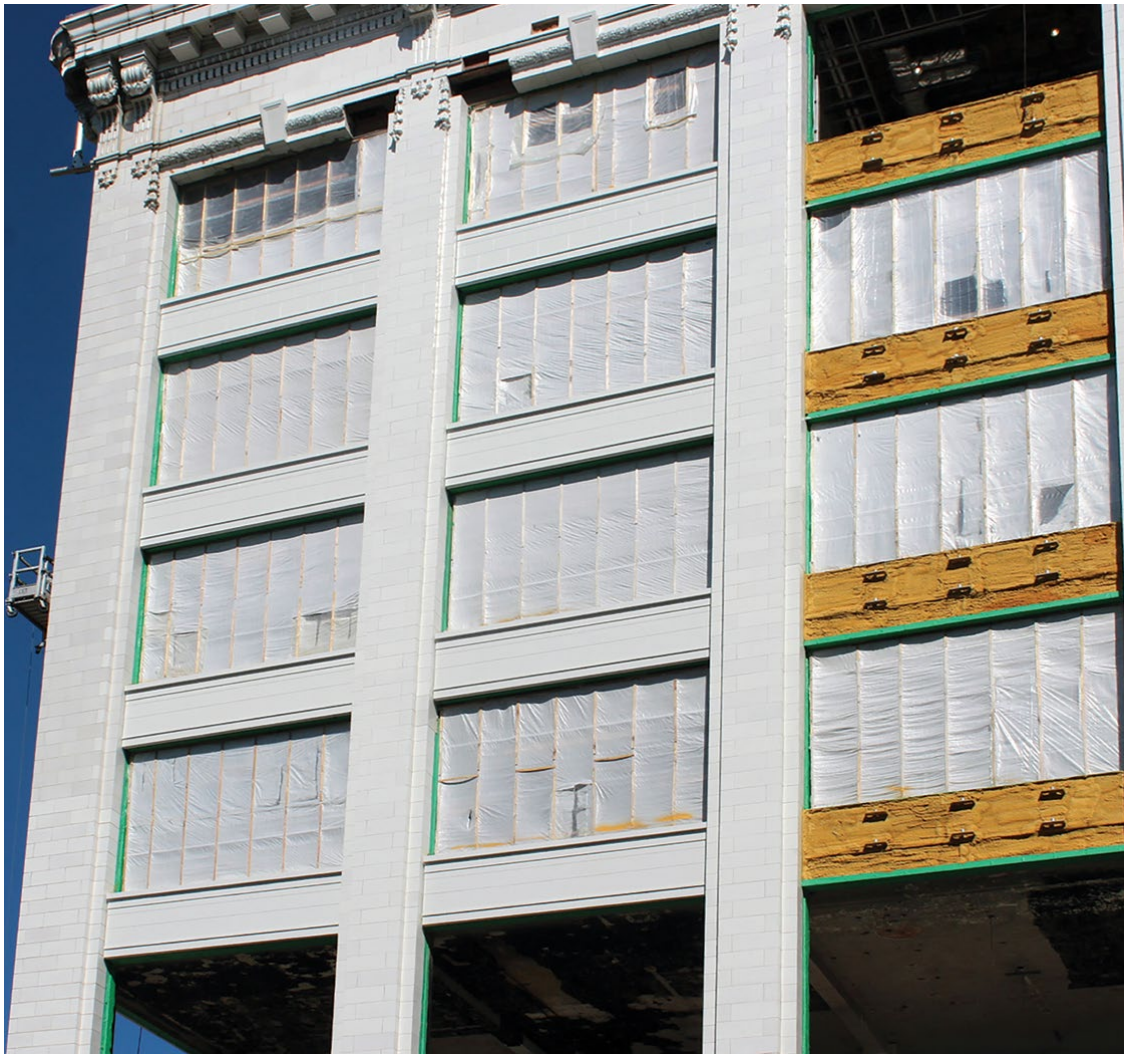
*Figure 18. Missing historic terra cotta spandrel panels on all floor levels were recreated utilizing glass fiber reinforced concrete (GFRC) replacements. New spandrels were fabricated as individual components and attached with metal clips between historic terra cotta piers. Photo: Kris Frail, Dewberry.*

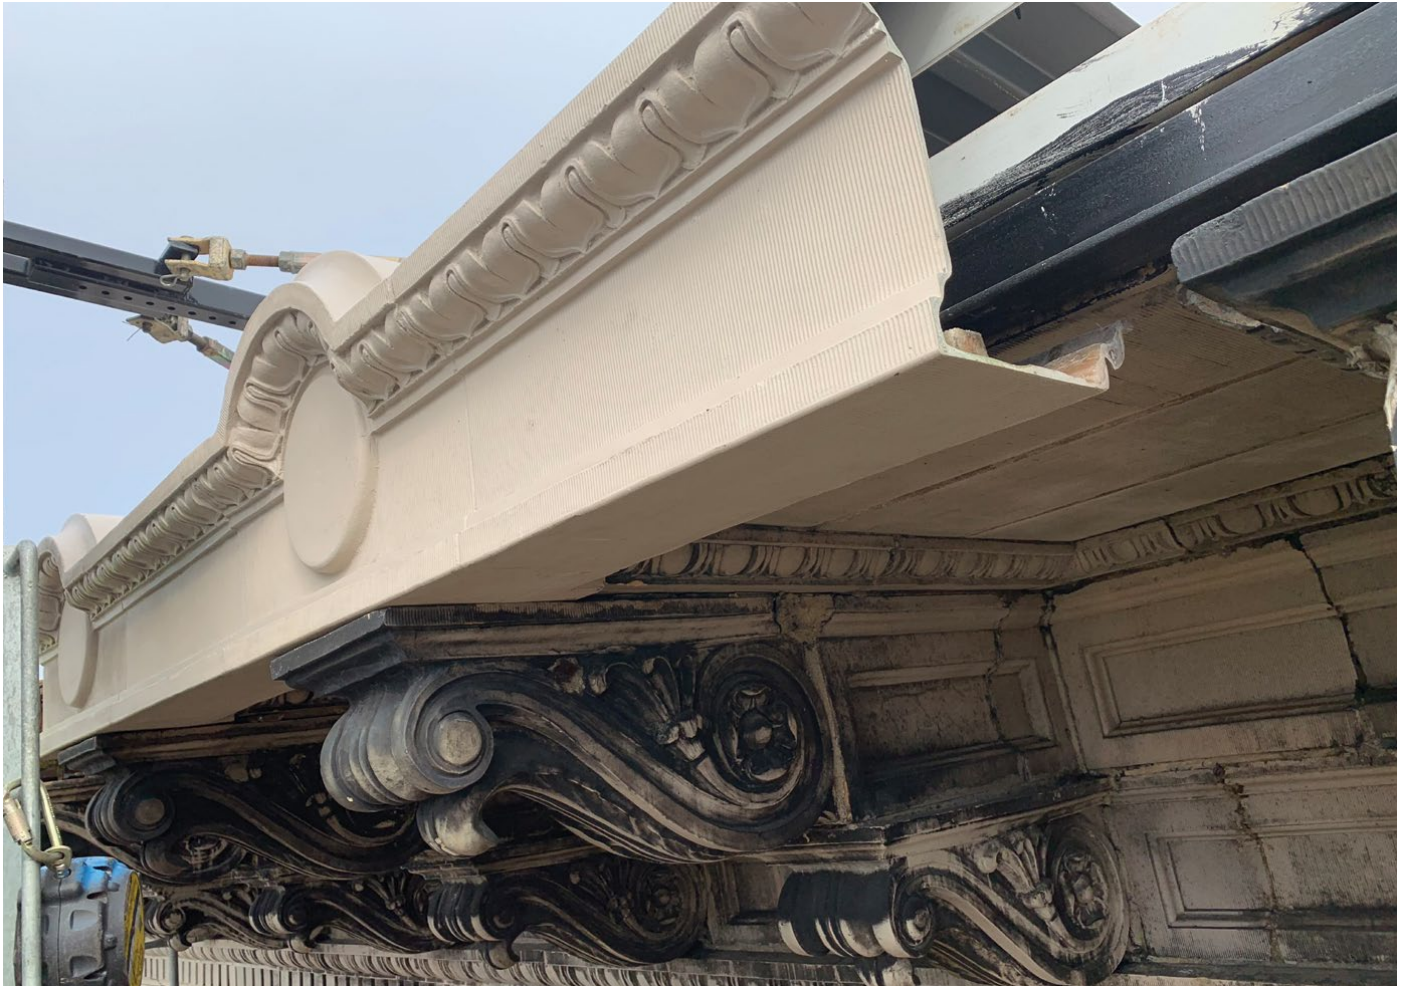
Figure 19. A new, lightweight fiber reinforced polymer is attached to a new metal armature to replicate damaged and missing elements of a terra cotta cornice. Photo: Quinn Evans.

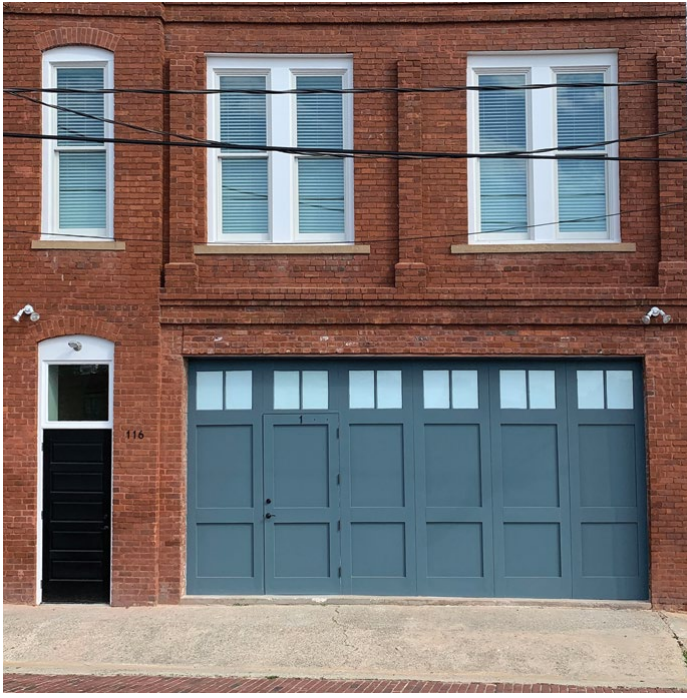
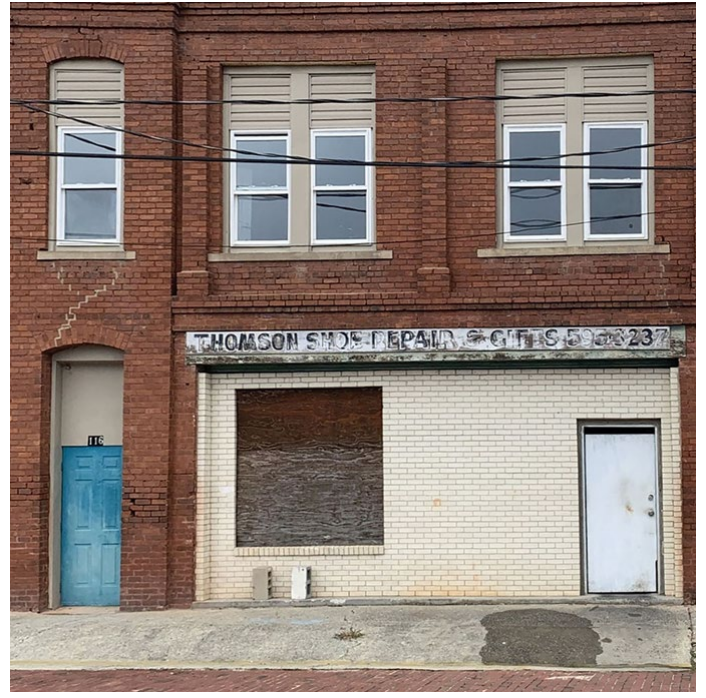
Figure 20. Cement board was used to replace a non-historic infill and mimics the configuration of a typical vehicular door of the period.  
Photos: Historic Augusta.

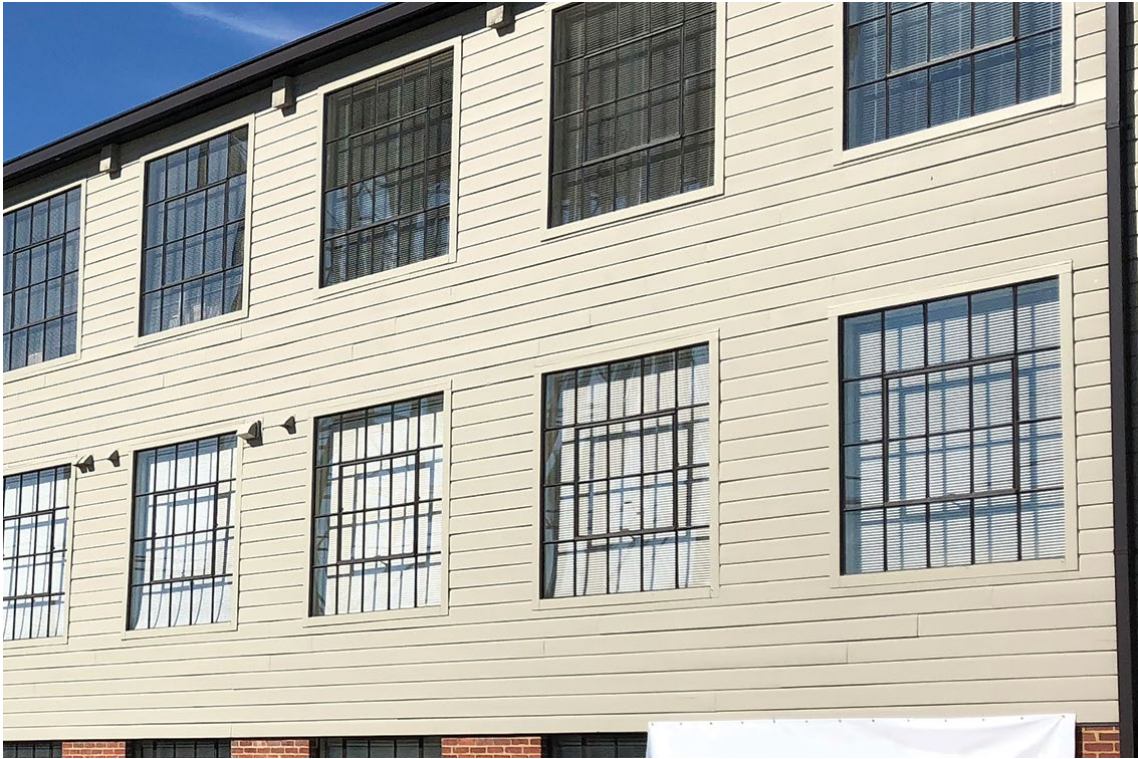
*Figure 21. A mineral polymer composite siding was available in the profile very similar to the historic siding. The replacement siding was used where the original material was almost completely missing beneath a more modern covering. Areas where the original wood was largely intact were replaced with matching wood to sustain more of the material integrity of the building. Photo: Belk Architecture.*

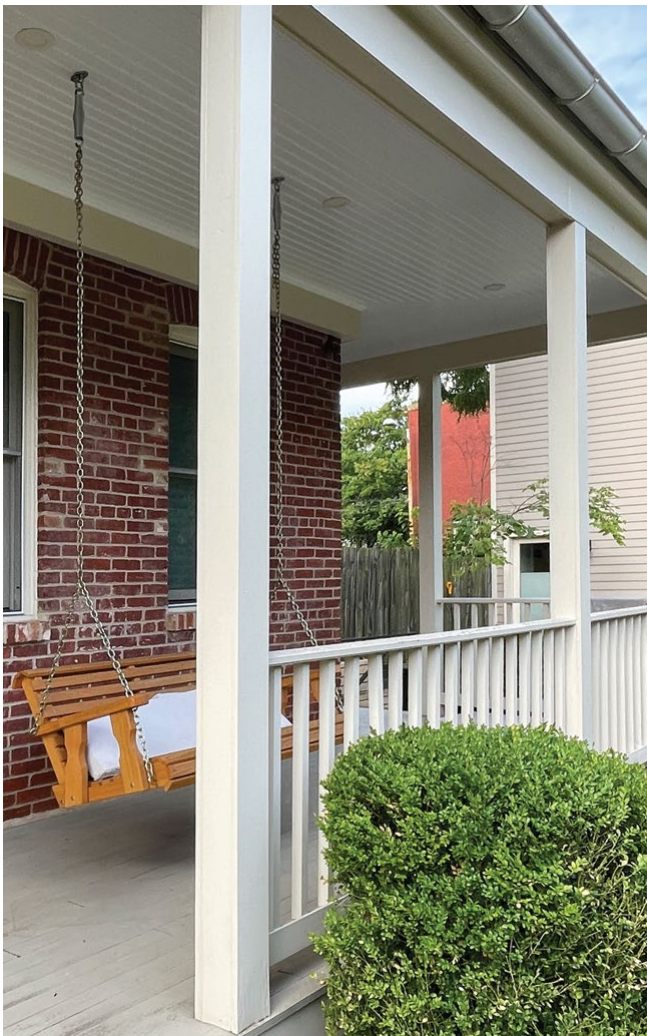
*Figure 22. A porch was reconstructed using posts fabricated on site from a smooth-surface cellulose/polymer composite material. Though the face of the posts are painted, the lack of paint on the bottom at the cut ends is not consistent with manufacturers' recommendations. This treatment will allow moisture to be absorbed, shortening the life of the new replacement feature. Photo: John Sandor, NPS.*

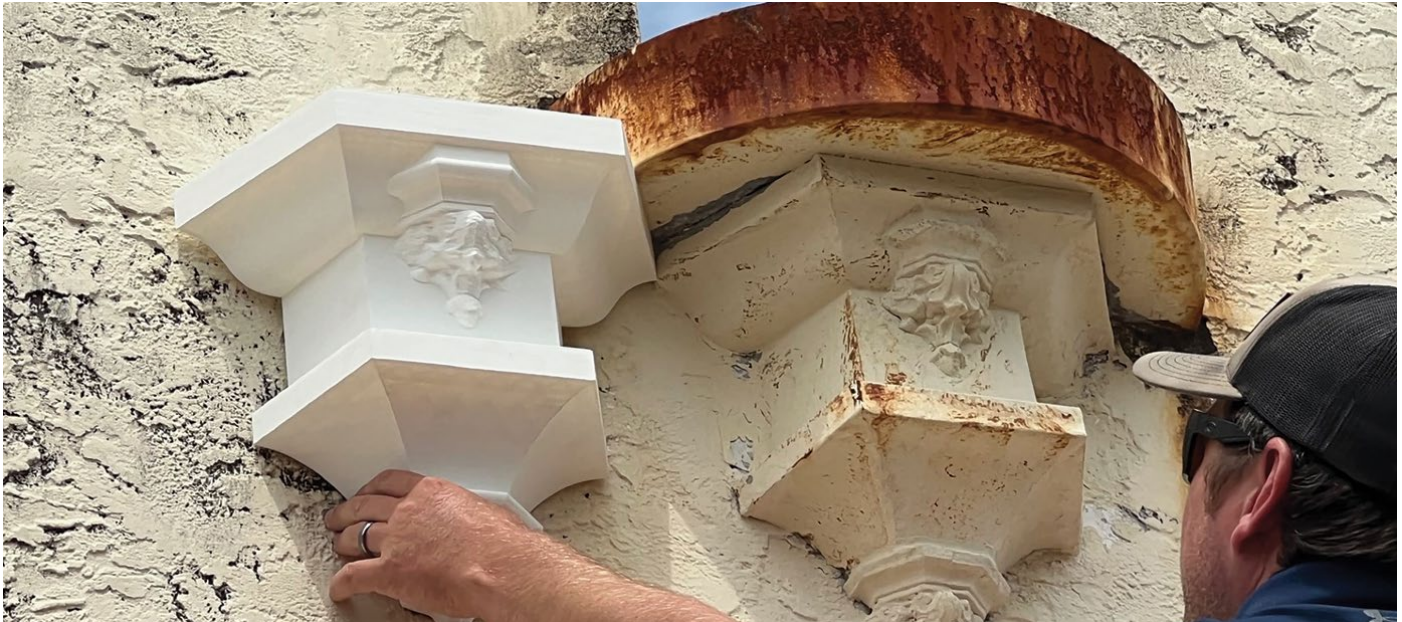
Figure 23. 3-D printing using various polymers is occasionally used to replicate missing metal or wood features. This new application is continually being refined, but the application can be successful when a painted, lightweight feature needs to be replicated. Photo: NPS.

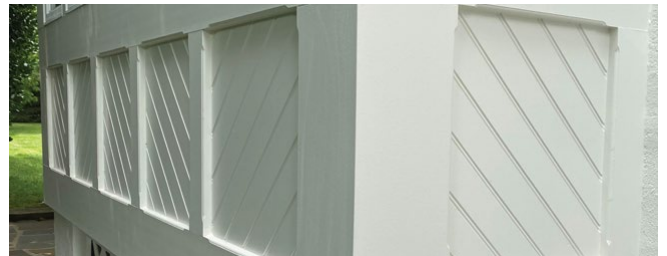
*Figure 24. Cellular PVC when painted can be used to replace deteriorated wood features. This beadboard set in a wood frame was not historically designed to shed water effectively and had deteriorated. Cellular PVC was able to match the appearance of the wood details, while its properties were well matched to the shady location, painted finish, and limited size and configuration within the overall assembly; thus, it should provide a long-lasting solution for this application. Photo: Jennifer Balson Alvarez, NPS.*
